## **Visual Inspection Report**

### **The P2-level Parking Garage Under Building 5**

Project: The Village at Palisades, Olympic Valley, CA 94146

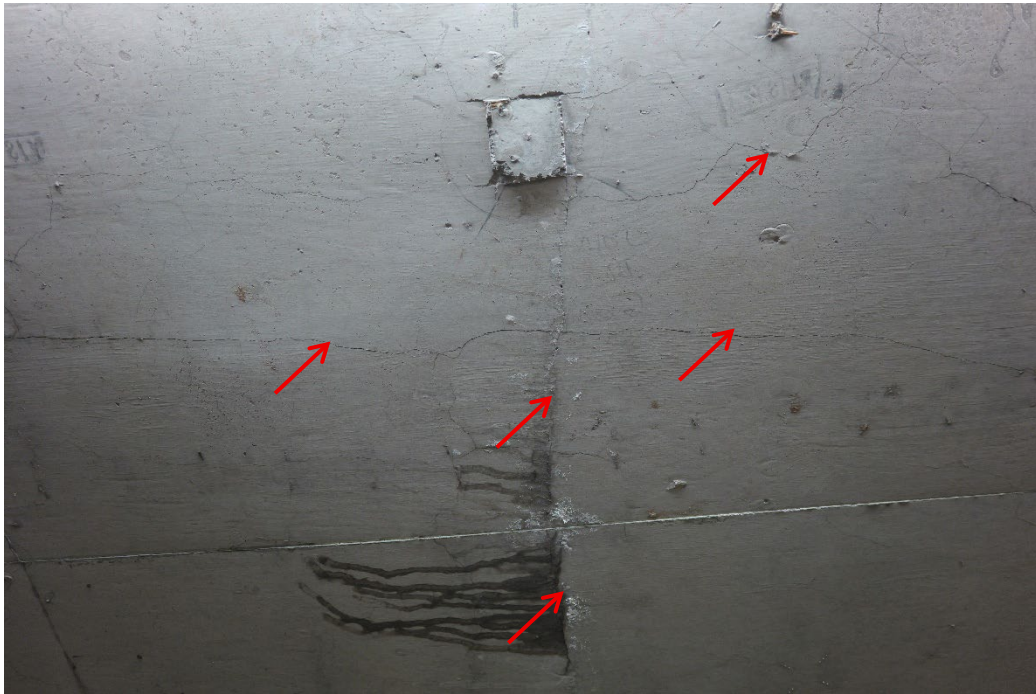
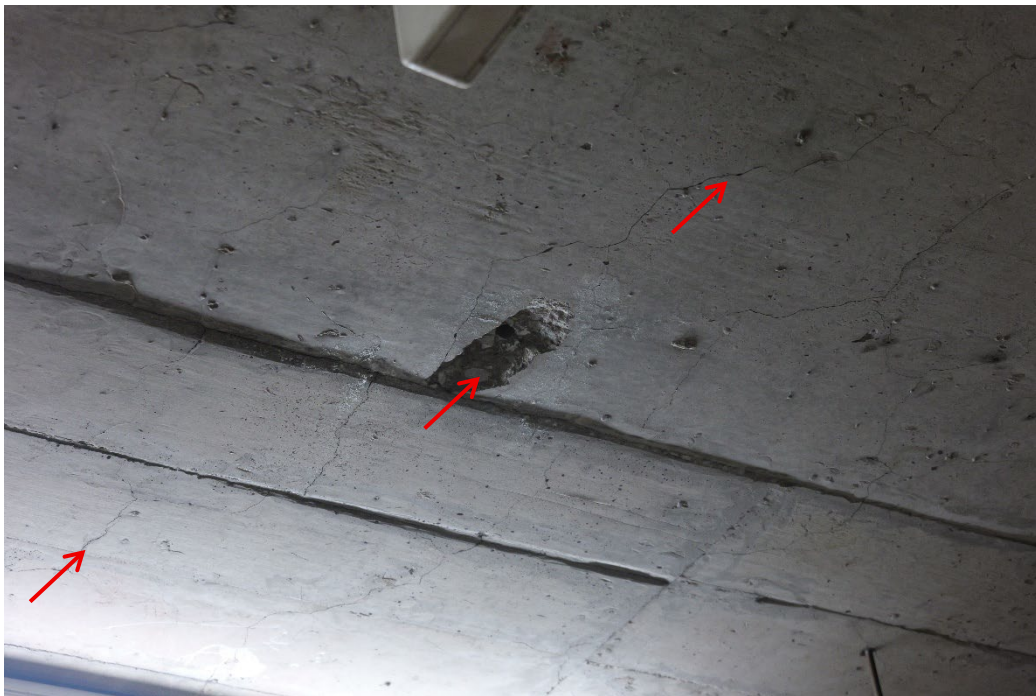
**Photographs 1 and 2** show crisscrossing cracking in the ceiling slab at **Location #1**. Efflorescence and localized spalling were observed. **22 Station**

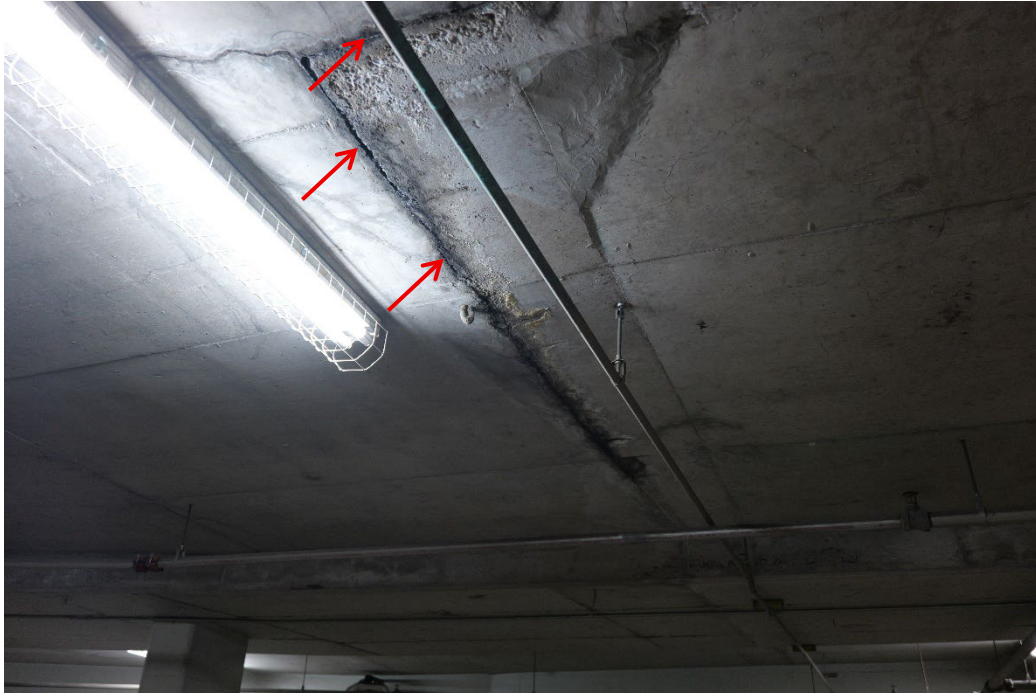
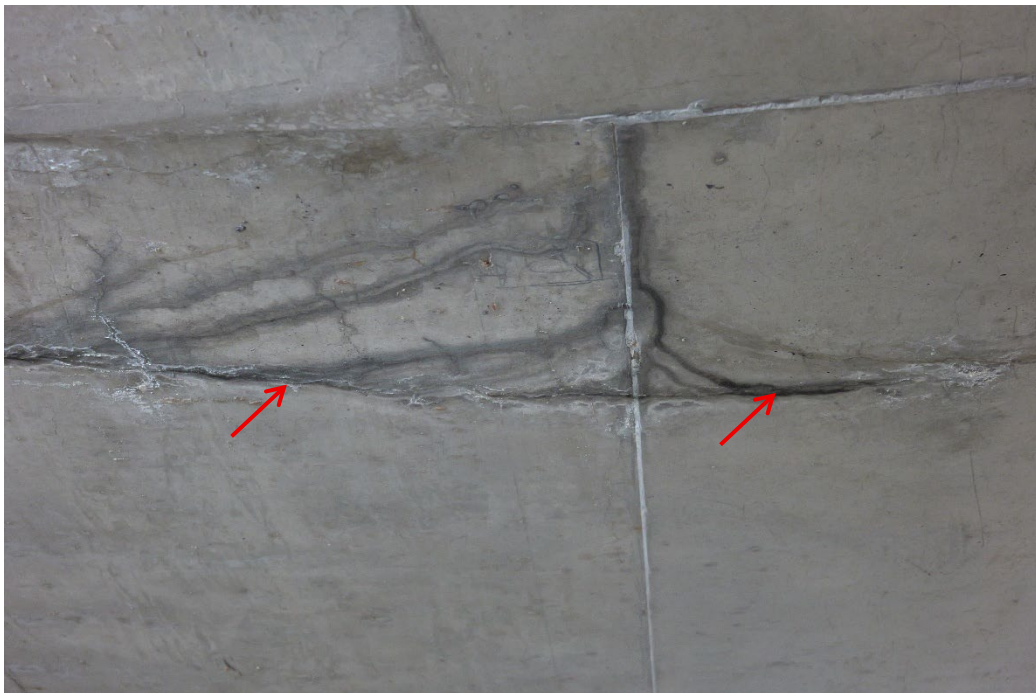
**Photographs 3 and 4** show conditions at **Location 2**, where crisscrossing cracks are visible in the ceiling slab. Evidence of possible leakage through a construction joint, along with associated efflorescence, is also present. Localized patch repairs are visible. **22 Station**

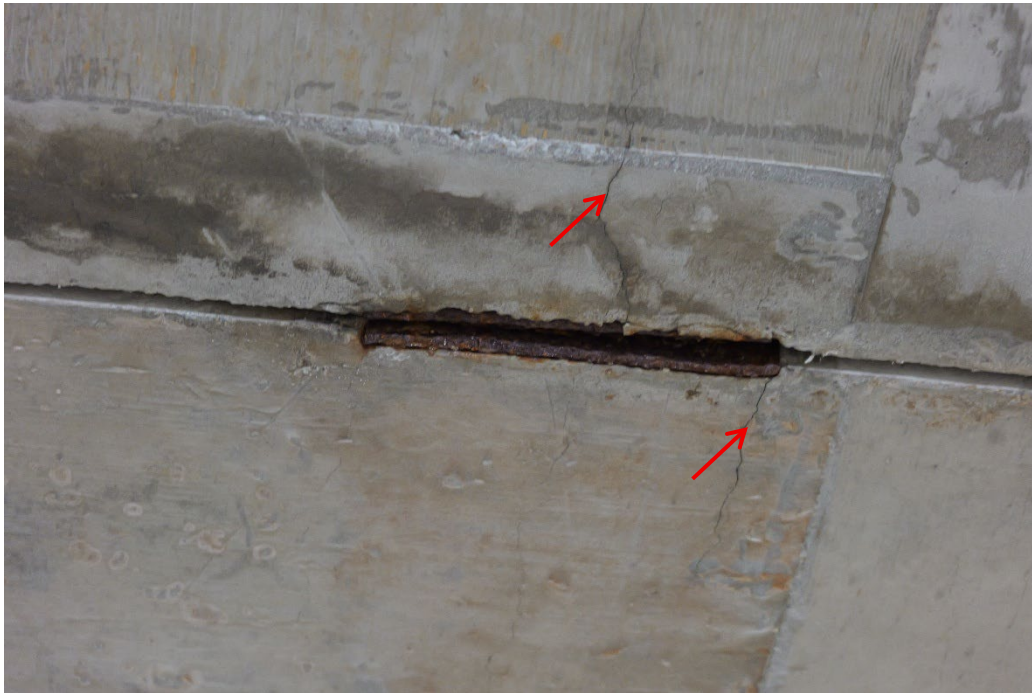
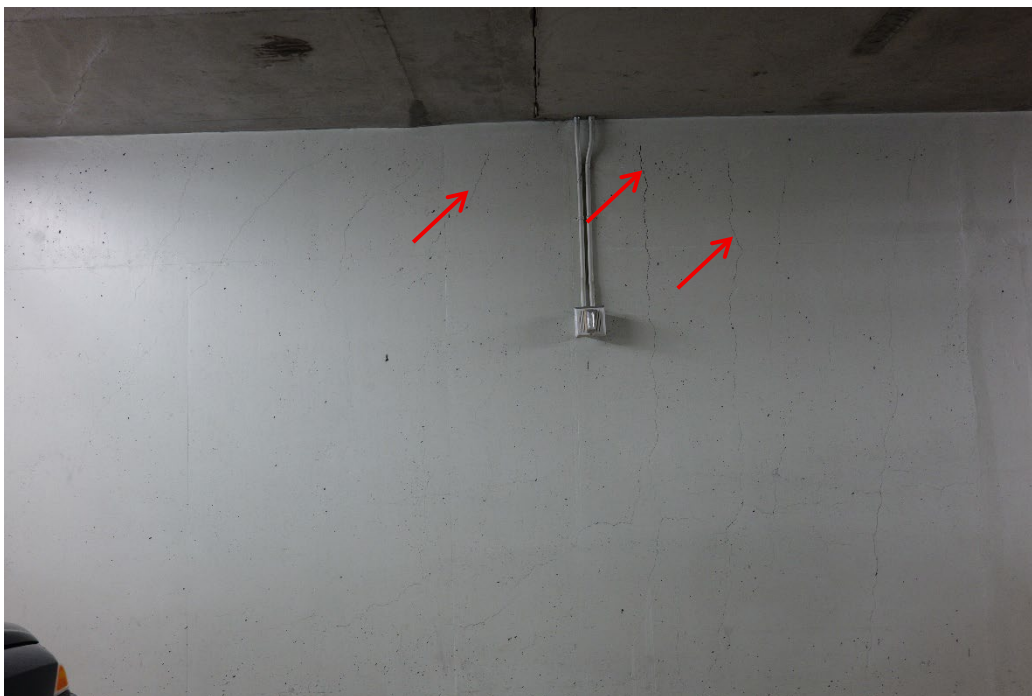
**Photographs 5 and 6** show **Location 3**, where radial cracking is visible in the ceiling slab adjacent to the construction joint and metallic inserts. Multiple vertical cracks are also visible in the retaining wall.

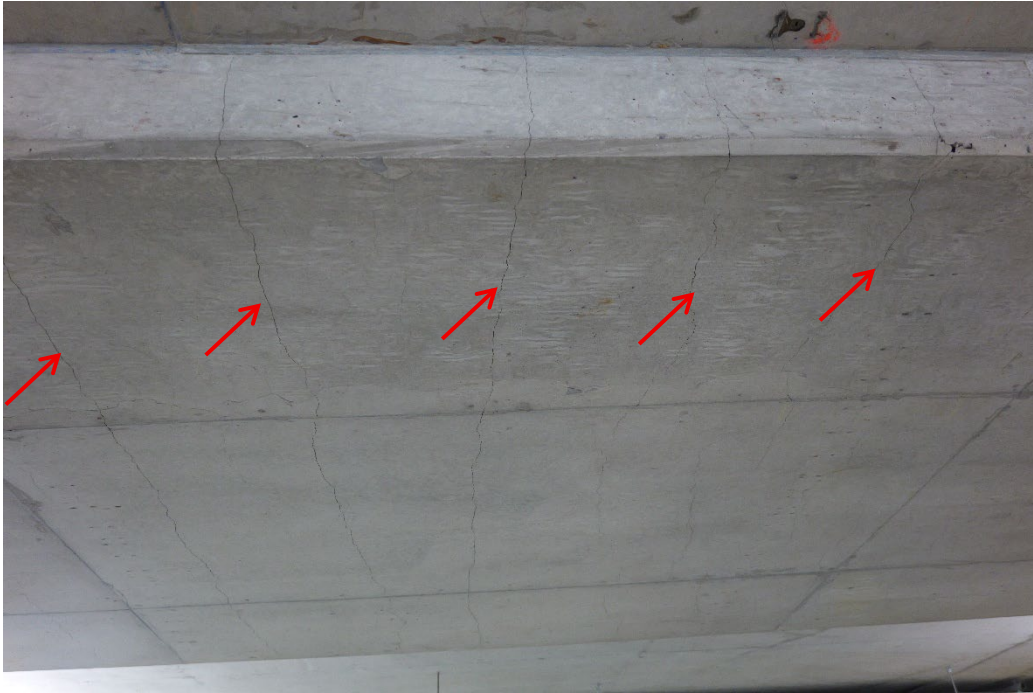
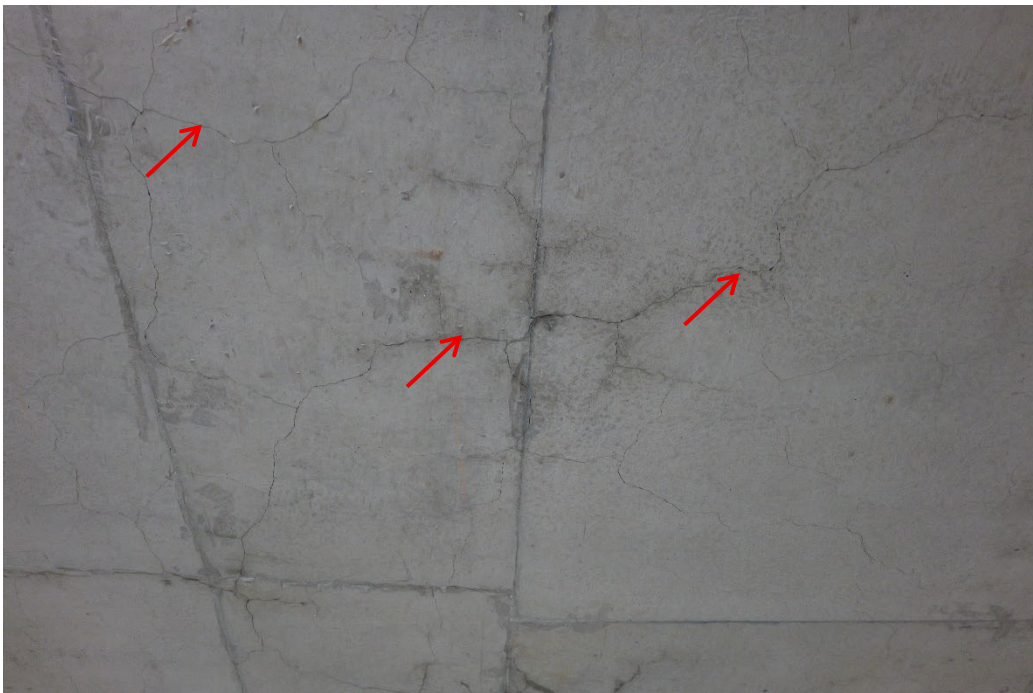
**Photographs 7 and 8 show Location 4**, where multiple parallel cracks of similar spacing are visible along the band beam soffit and continue onto the beam side faces. Crisscrossing cracks are also visible on the slab soffit. **22 Station**

- a) It is also recommended to verify the adequacy of as-built reinforcement in other slab bands subjected to similar cantilever loading conditions, to ensure that inadequate reinforcement conditions like those observed at locations B1 and B2 are not present elsewhere. **How will this be done? A repeat of the Phase I effort? Coring and testing?**

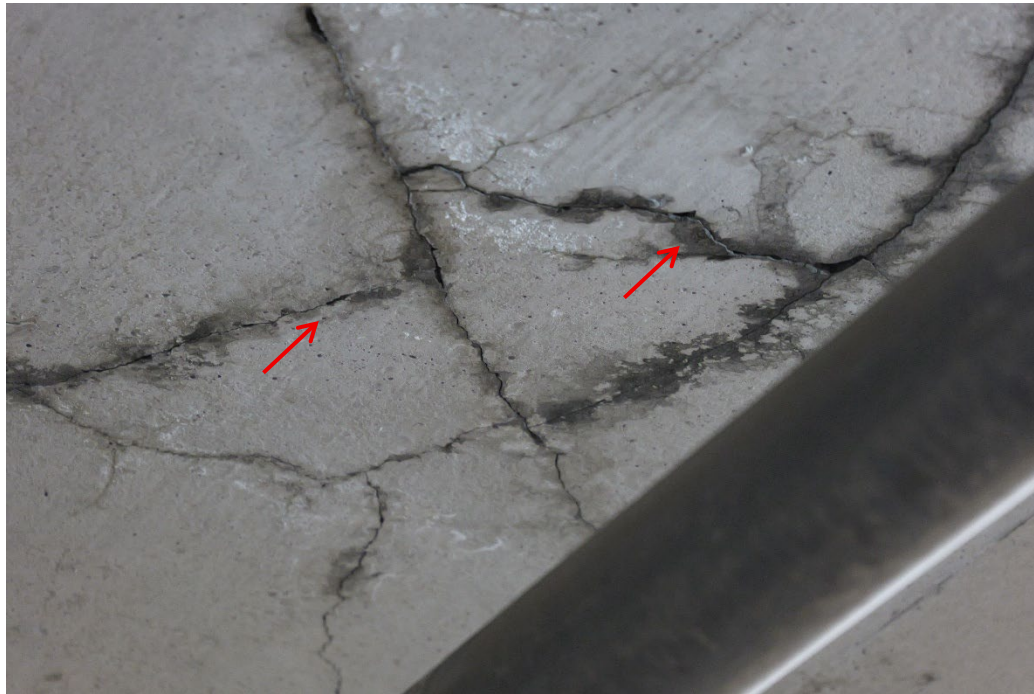
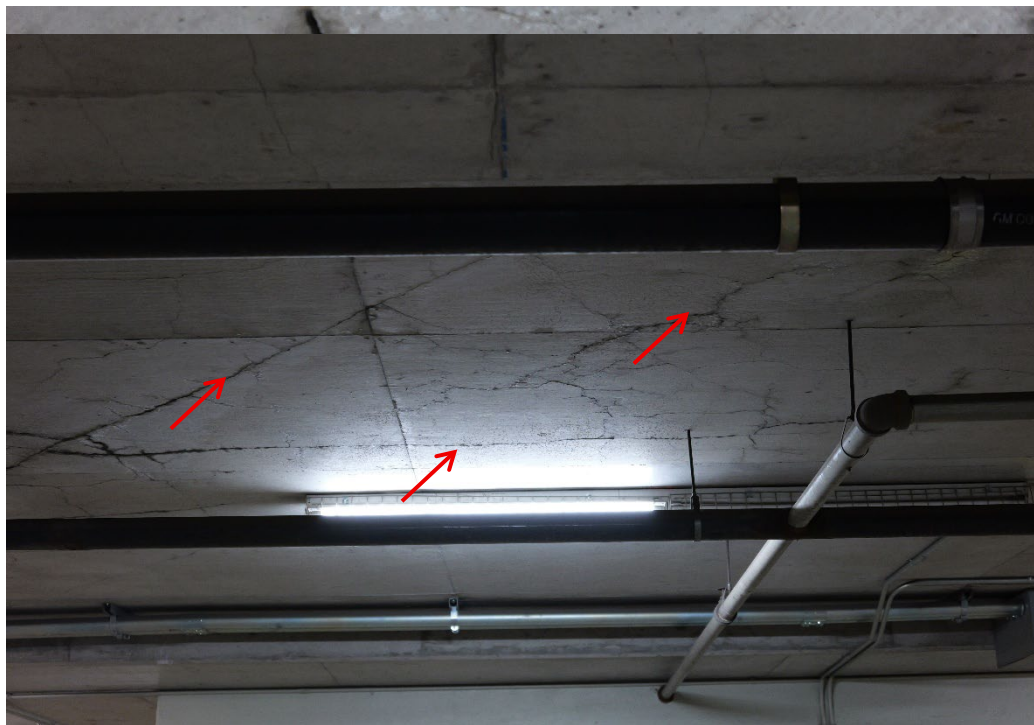
**Photographs 9 and 10** show **Location 5**, where multiple structural cracks of similar spacing are visible along the band beam soffit and continue onto the beam side faces. Crisscrossing cracks are also present on the slab soffit, with associated leakage and efflorescence. **22 Station**

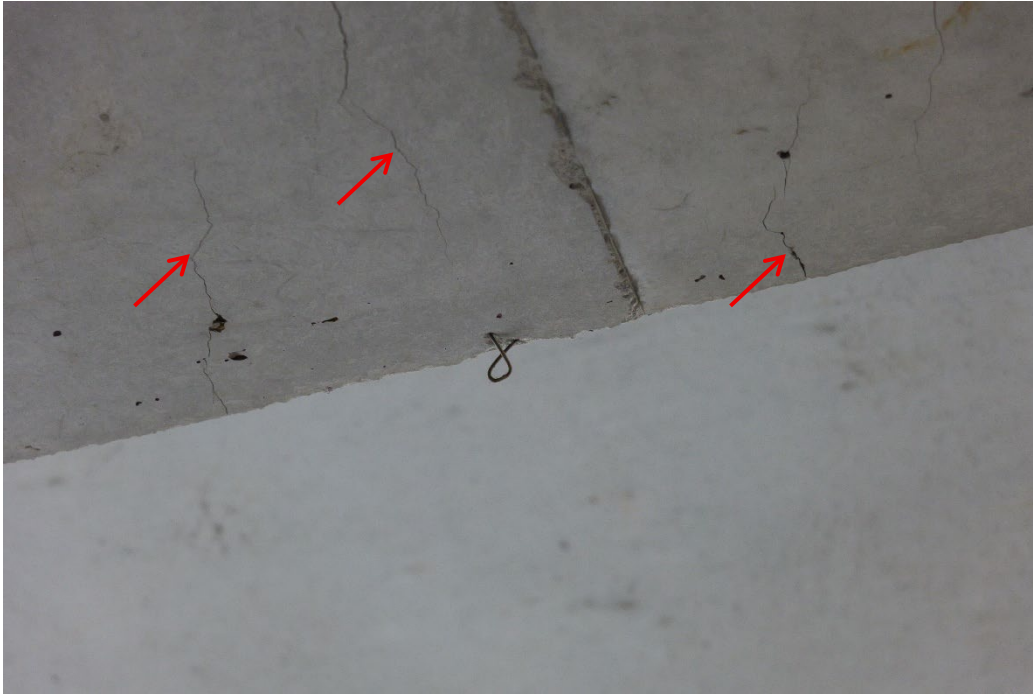
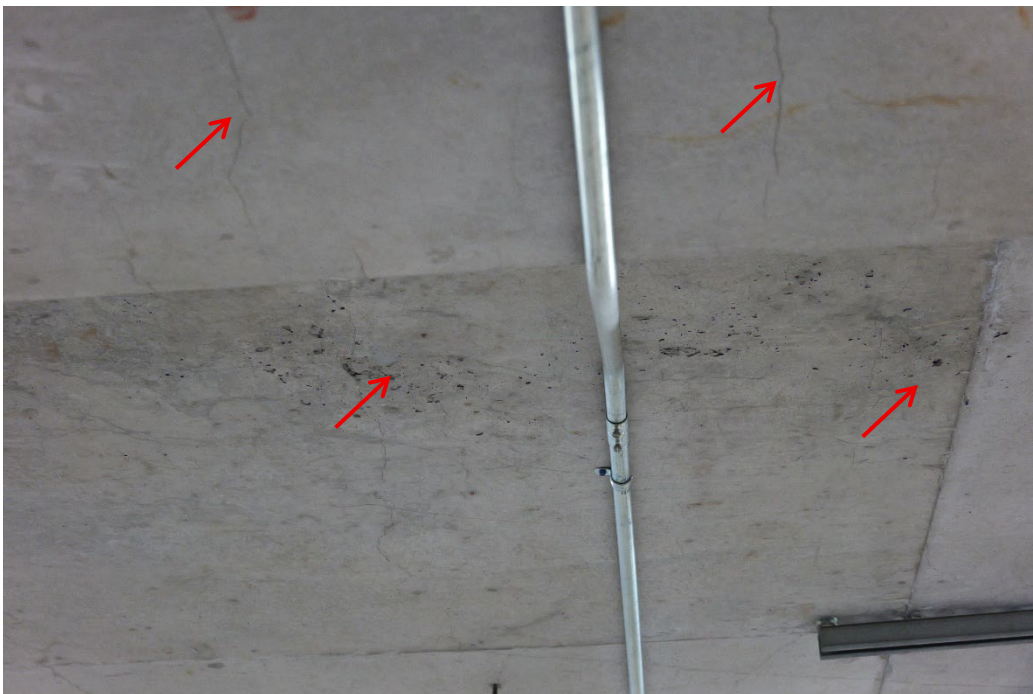
**Photographs 11 and 12 show Location 6, where cracking is visible in the slab at the retaining wall junction. Minor surface honeycombing and general slab cracking were also present.** 22 Station

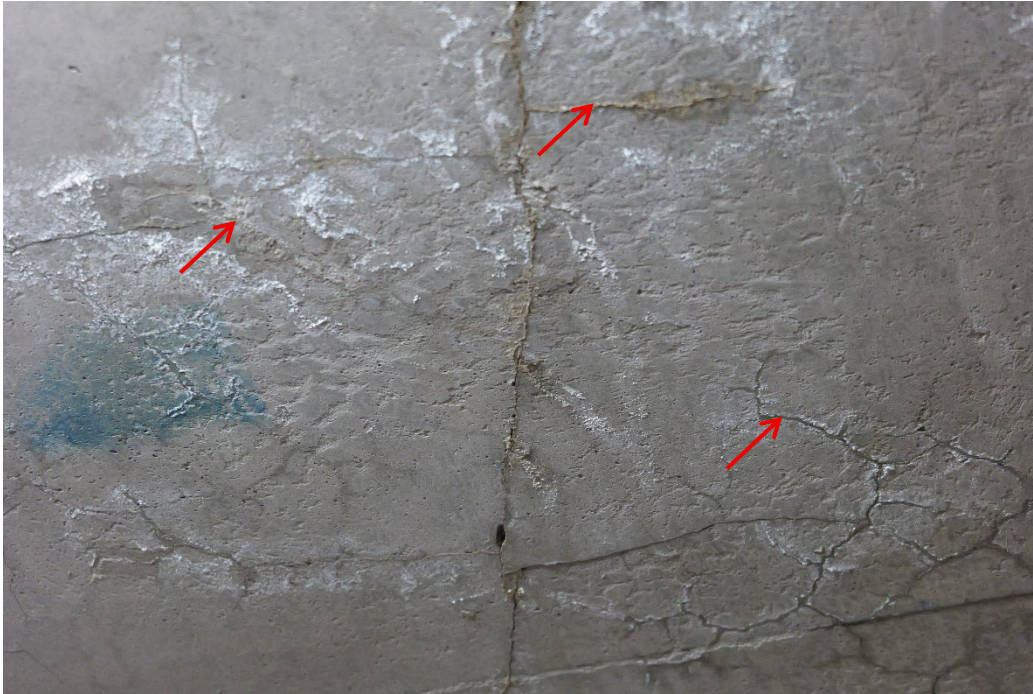
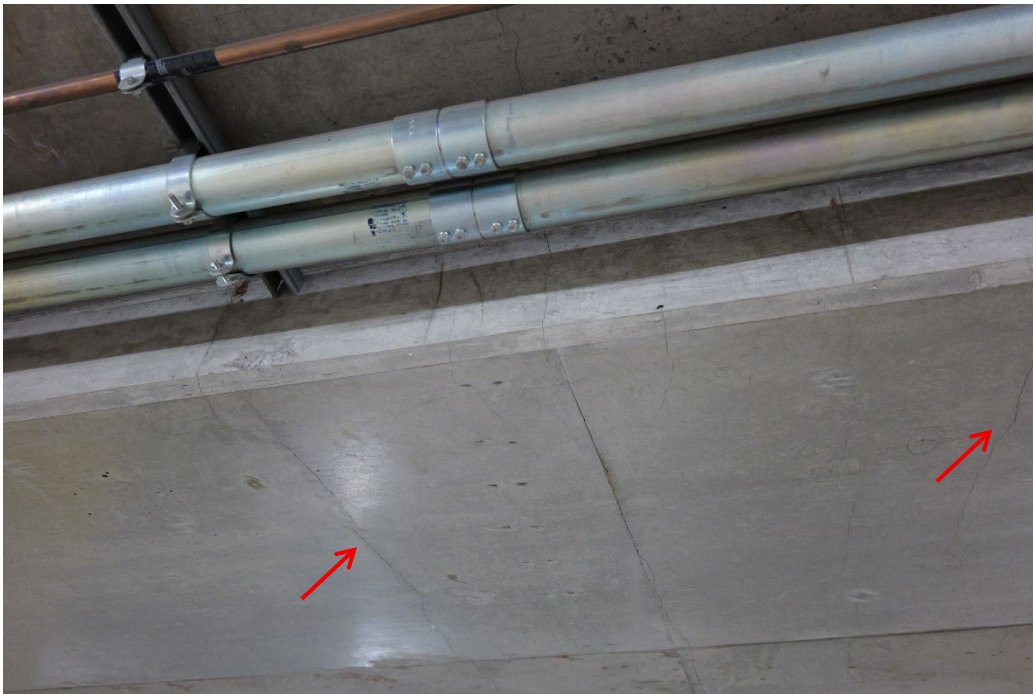
**Photographs 13 and 14 show Location 7, where cracking, leakage, and efflorescence are visible in the slab. Cracking is also visible in the band beam.**

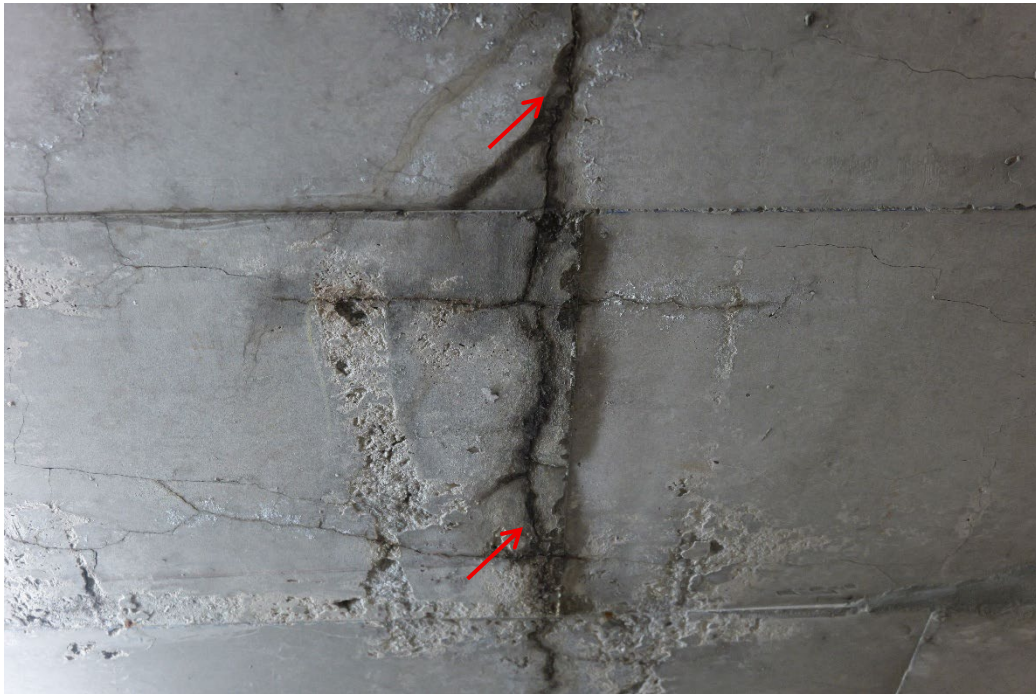
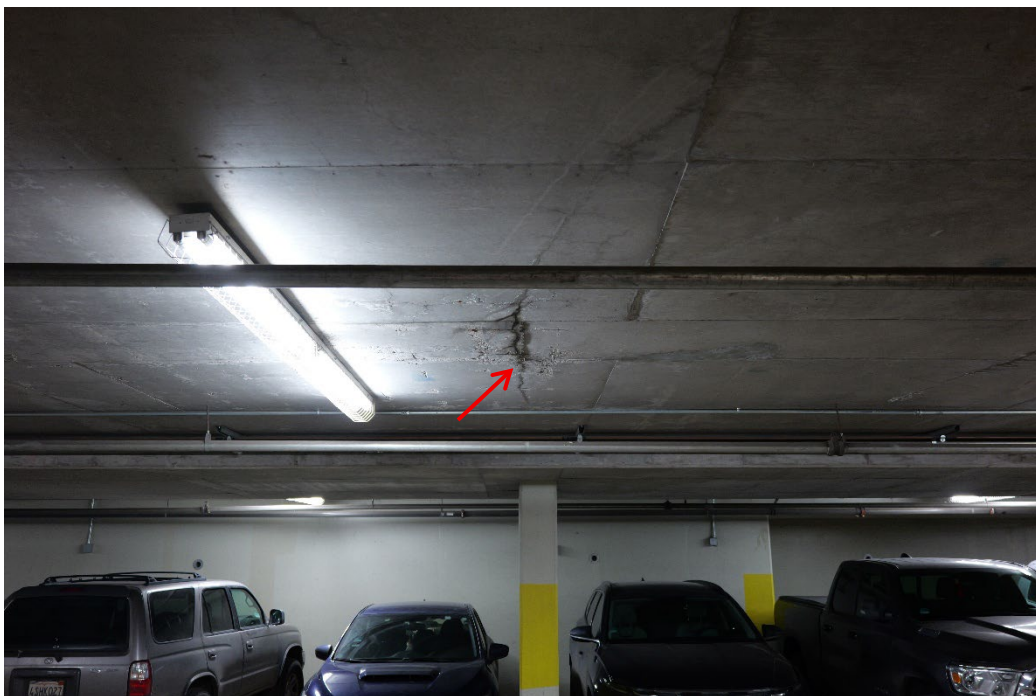
**Photographs 15 and 16 show Location 8, where cracking, leakage, and efflorescence are visible in the slab. Cracking was also visible in the band beam.** 22 Station Owners Association

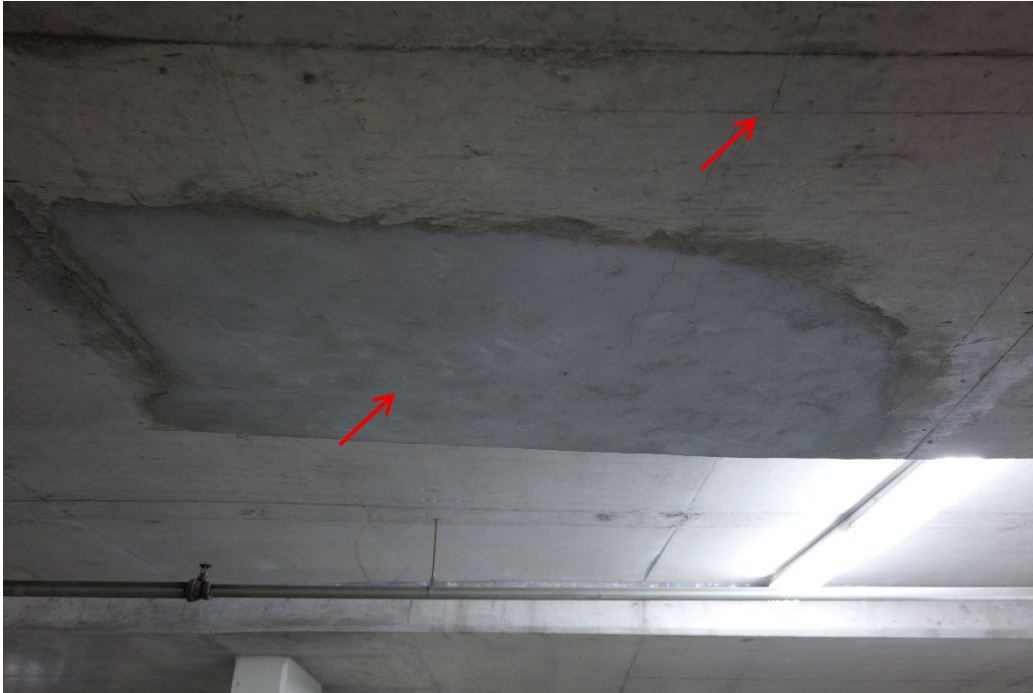
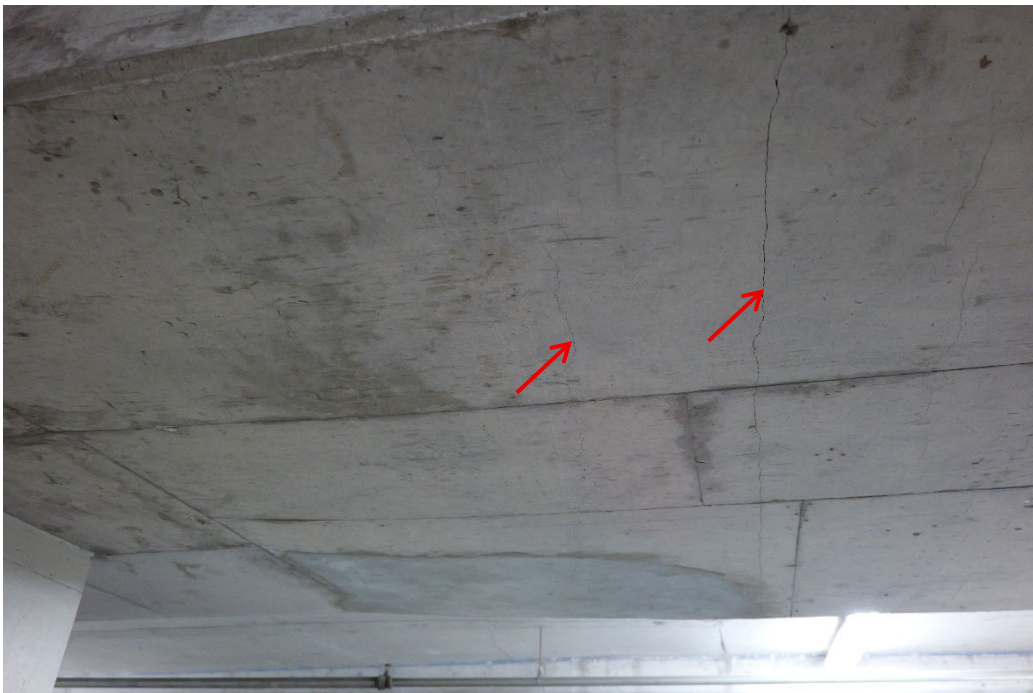
**Photographs 17 and 18 show Location 9, where parallel cracking is visible in the band beam, together with evidence of a prior patch repair.** 22 Station

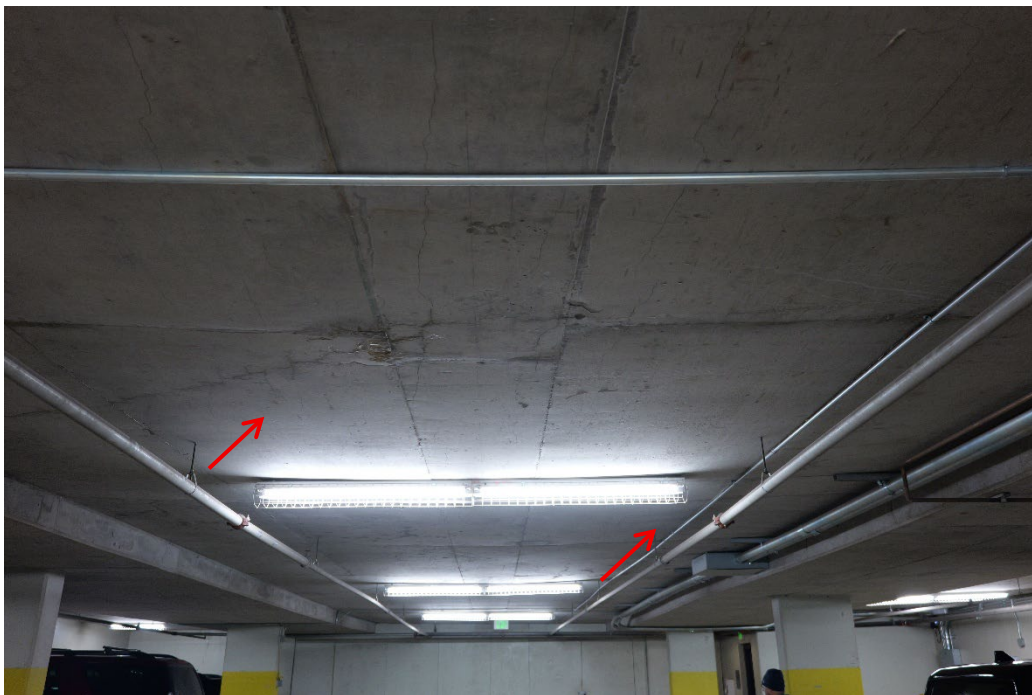
**Photographs 19 and 20** show **Location 10**, where parallel slab cracking and efflorescence are visible. A gap at the end of the light fixture suggests possible slab sagging, warranting further

evaluation.

- a. A detailed engineering review is recommended. Where necessary, appropriate remedial engineering solutions should be developed and implemented to mitigate the risk of future major distress. **What is a detailed engineering review? What are the risks? What are major distresses? Probability**

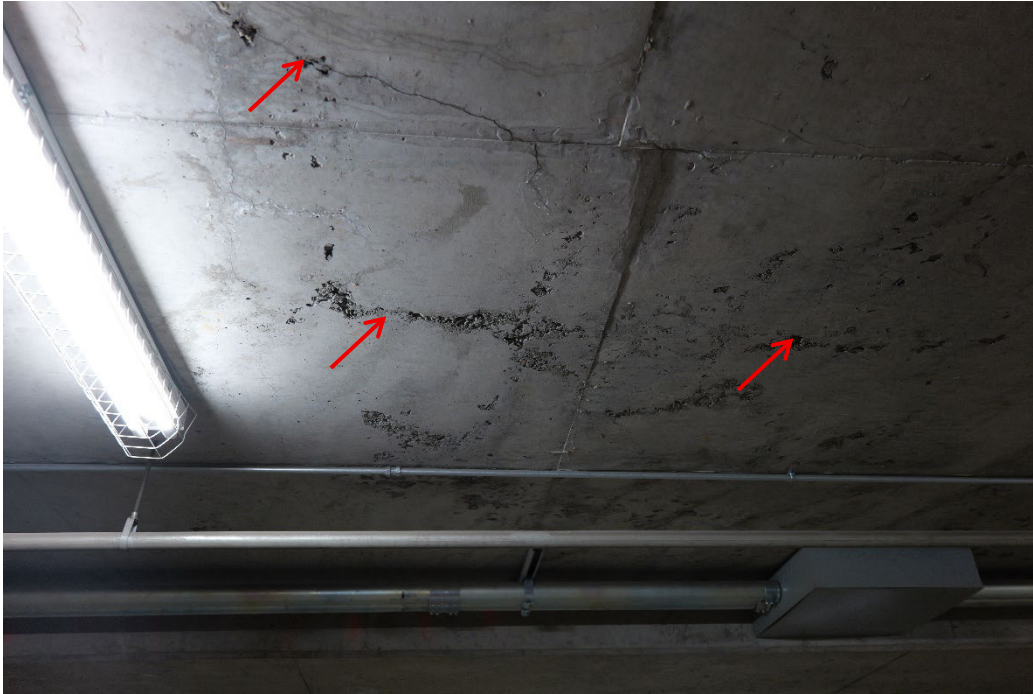
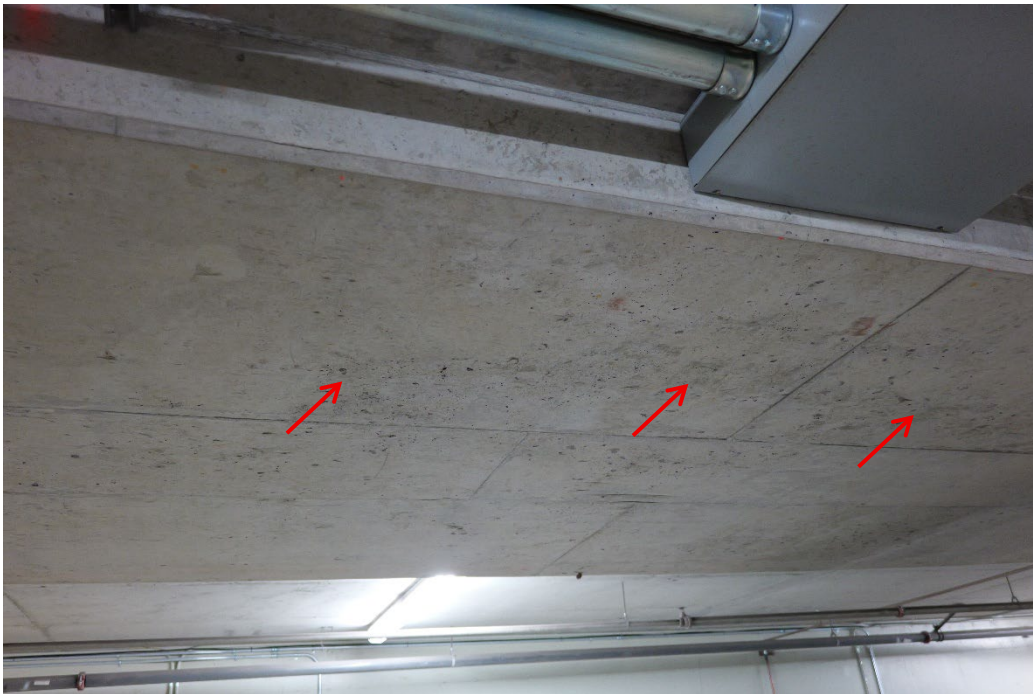
**Photographs 21 and 22** show **Location 11**, where concrete honeycombing and cracking are visible in the slab and band beam.

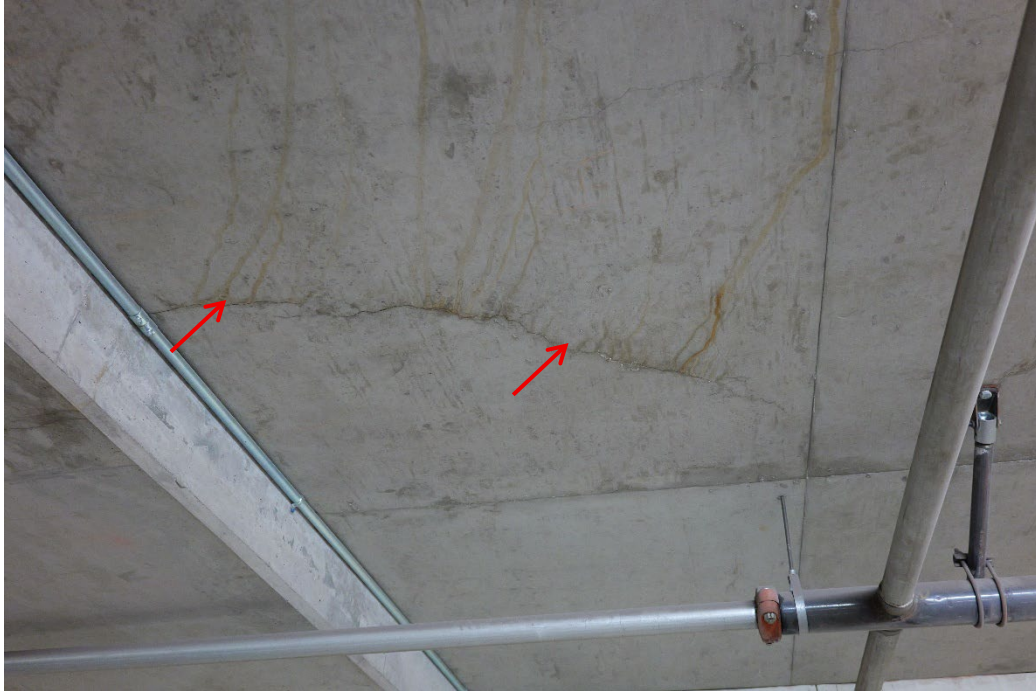
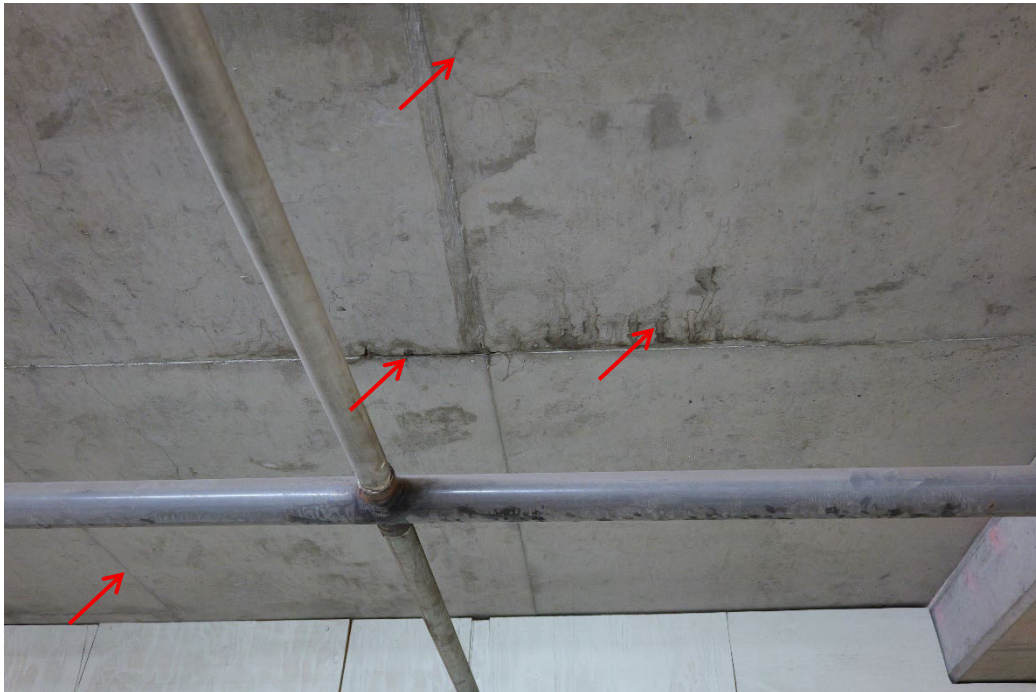
Photographs 23 and 24 show **Location 12**, where leakage was visible through cracks and construction joints. **22 Station**

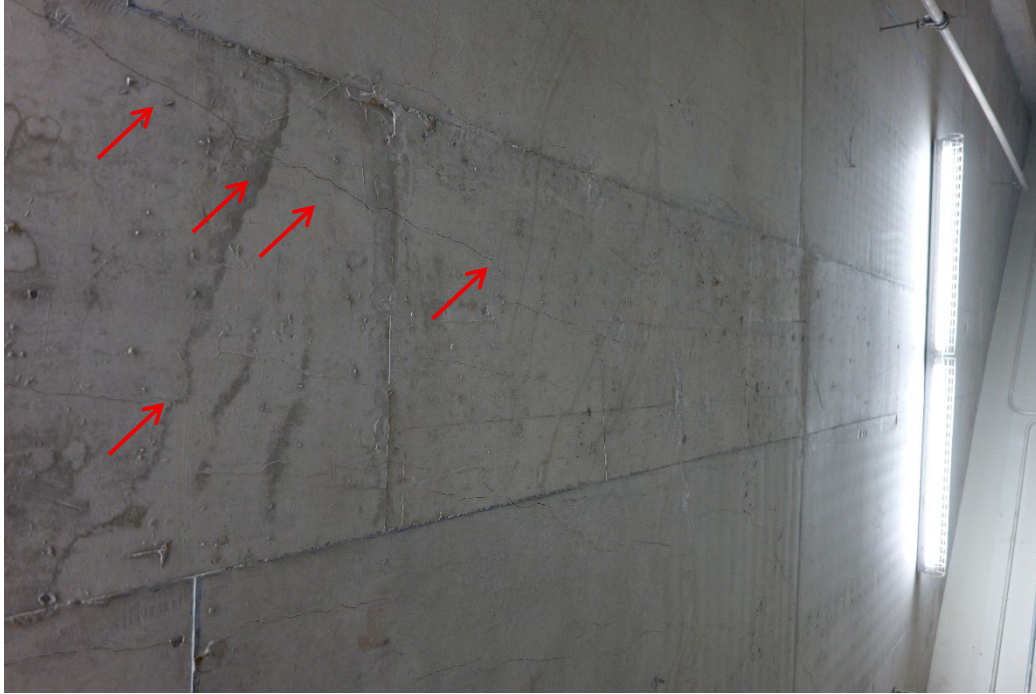
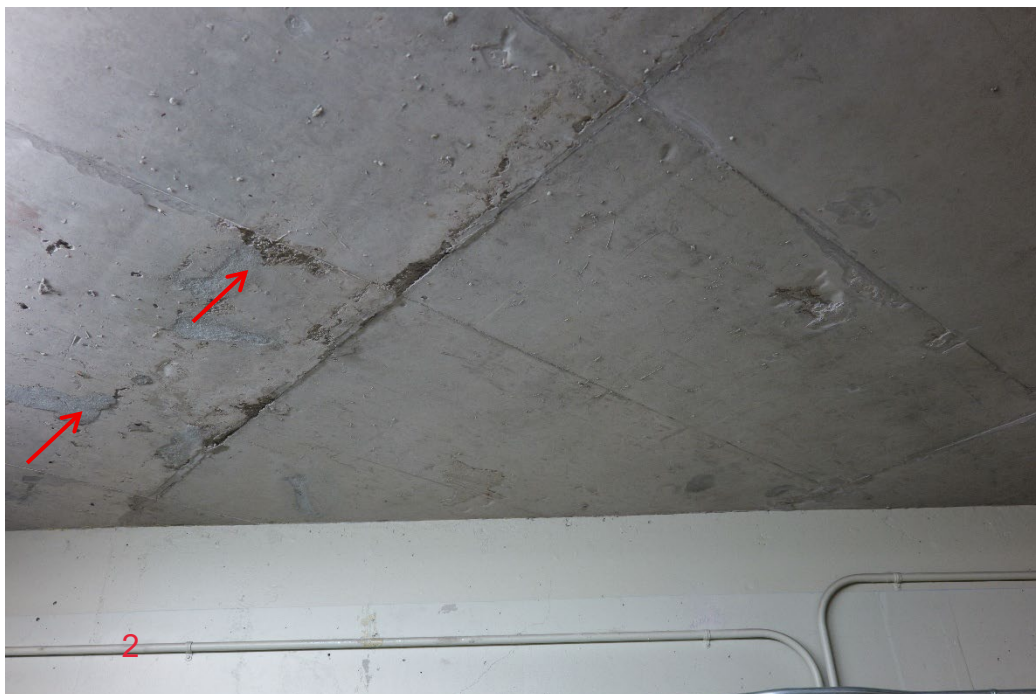
Photographs 25 and 26 show **Location 13**, where parallel slab cracking was visible.

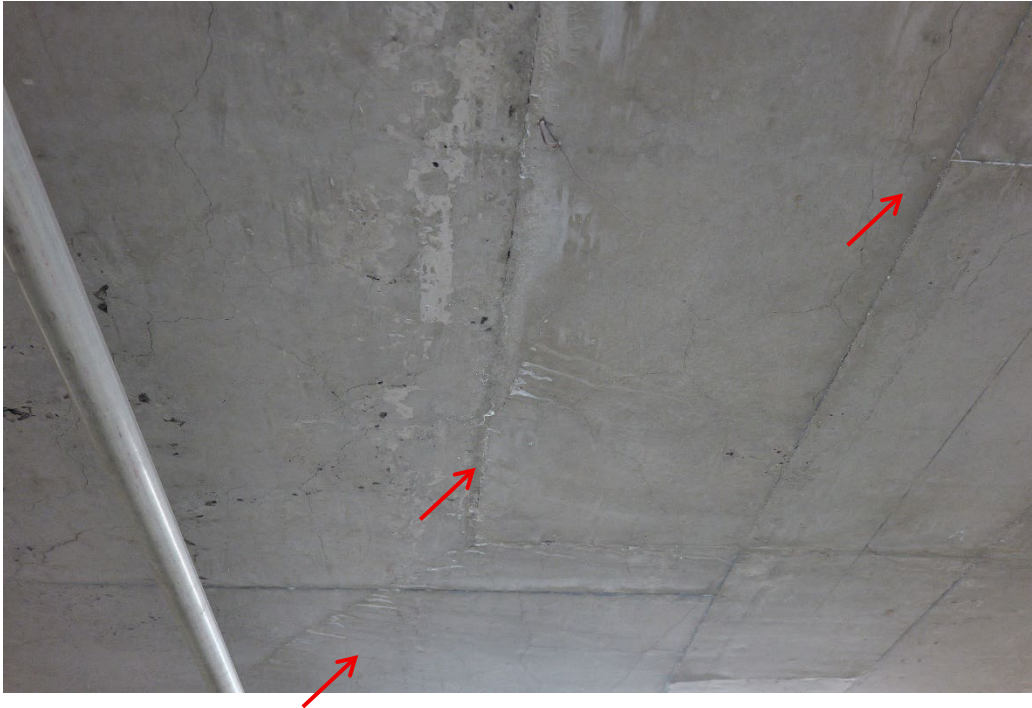
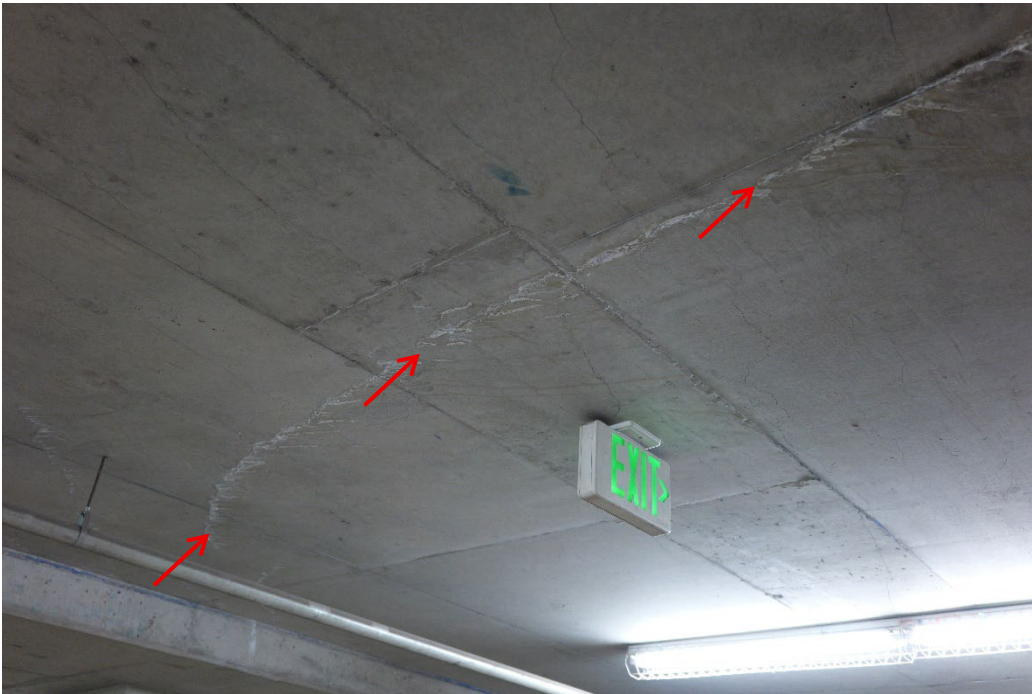
**Photographs 27 and 28** show **Location 14**, where slab cracking is visible, together with evidence of prior leakage and efflorescence.

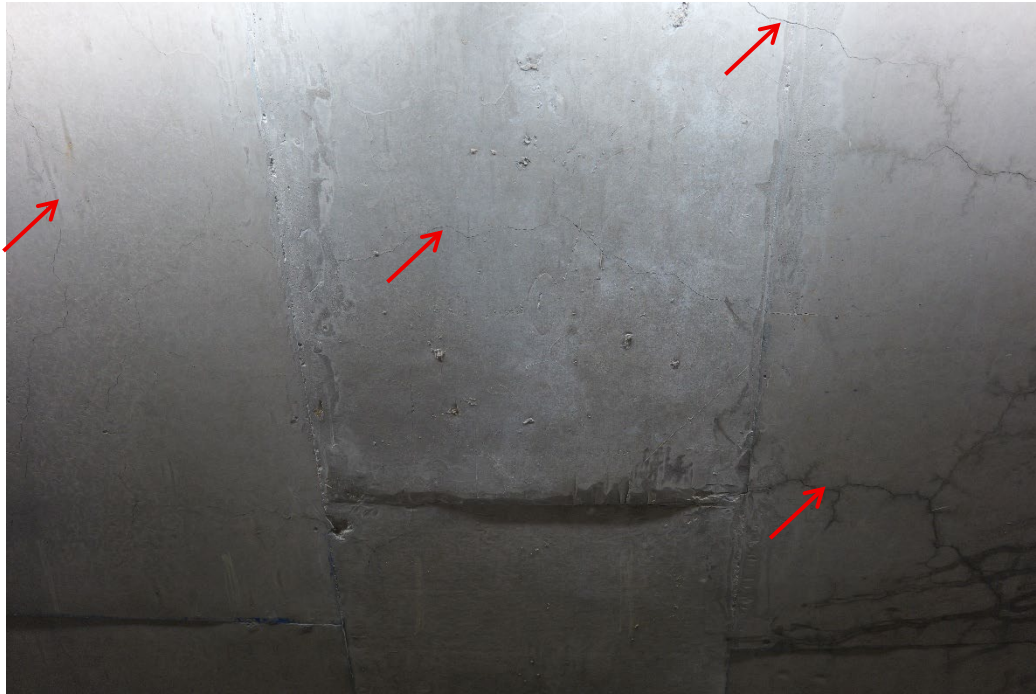
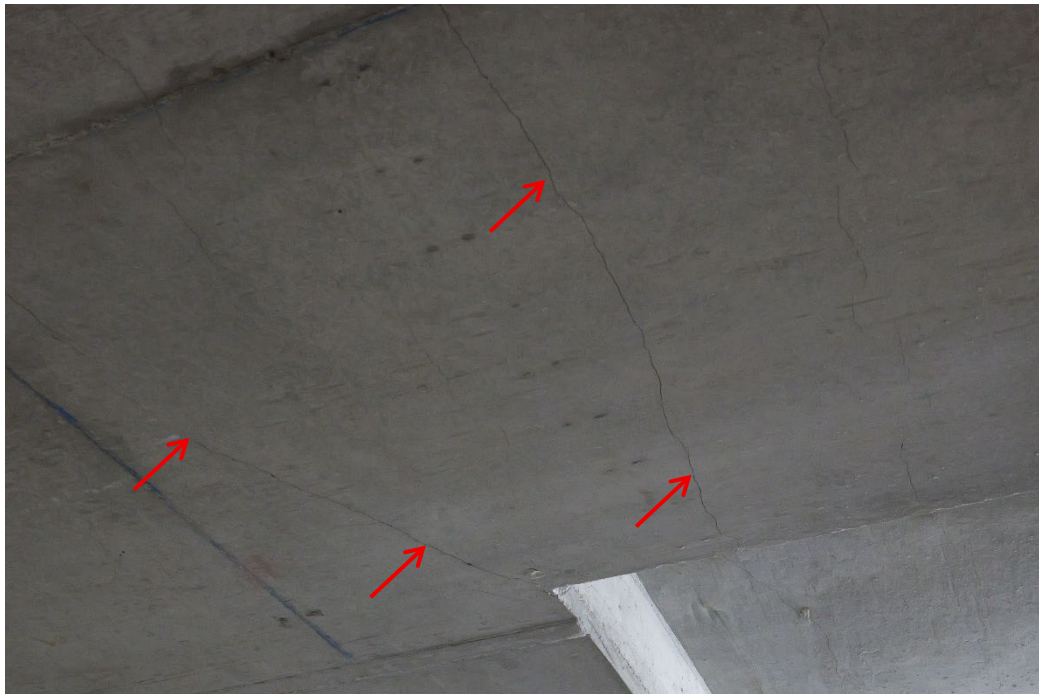
**Photographs 29 and 30** show **Location 15**, where cracking is visible in the slab and band beam. Efflorescence and leakage are also evident.

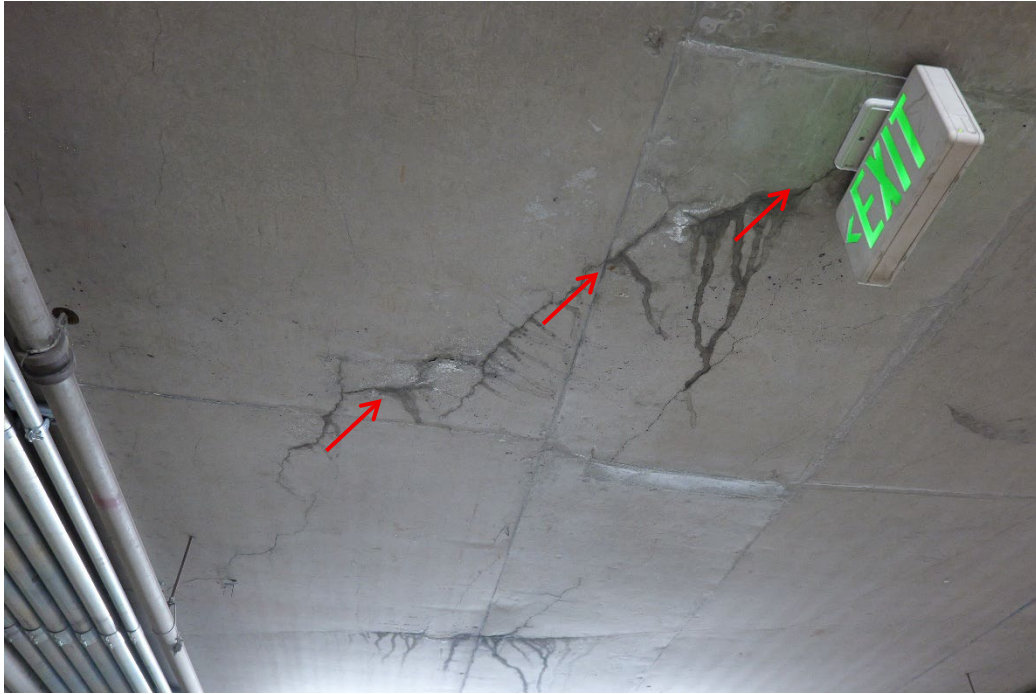
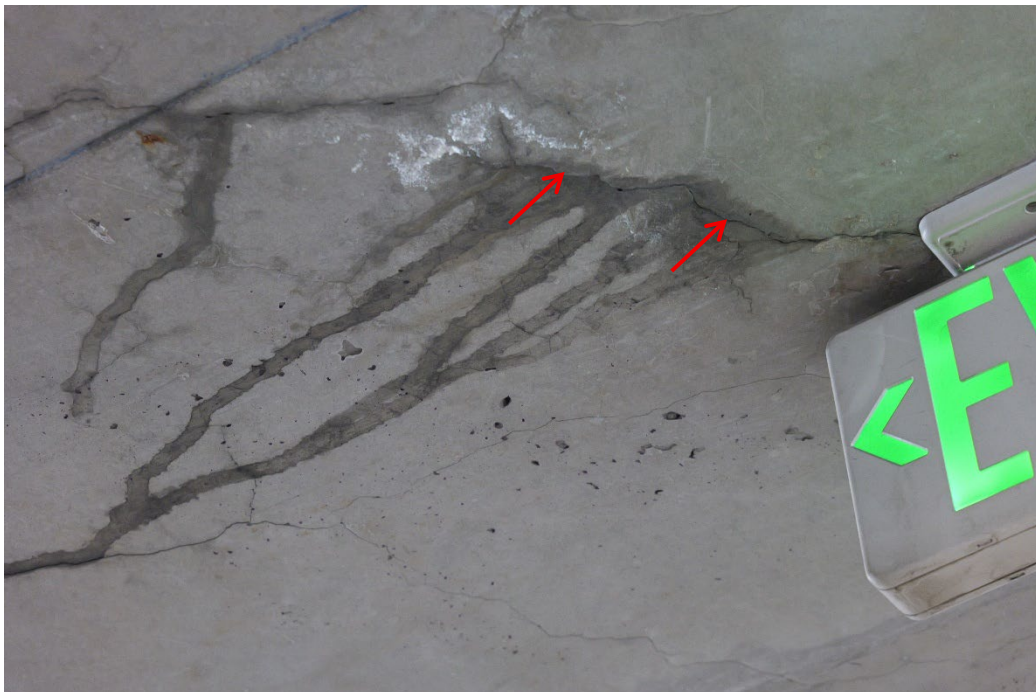
**Photographs 31 and 32** show **Location 16**, where crisscrossing slab cracks were visible, together with active leakage and associated efflorescence.
