## **Visual Inspection Report**

### **The P2-level Parking Garage Under Building 5**

Project: The Village at Palisades, Olympic Valley, CA 94146

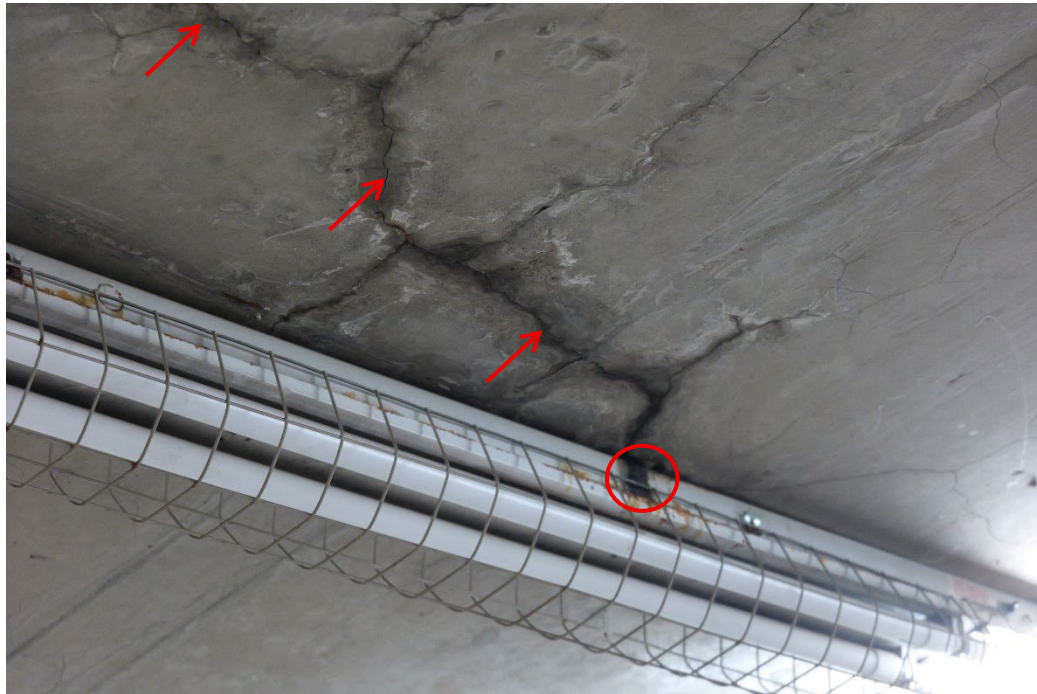
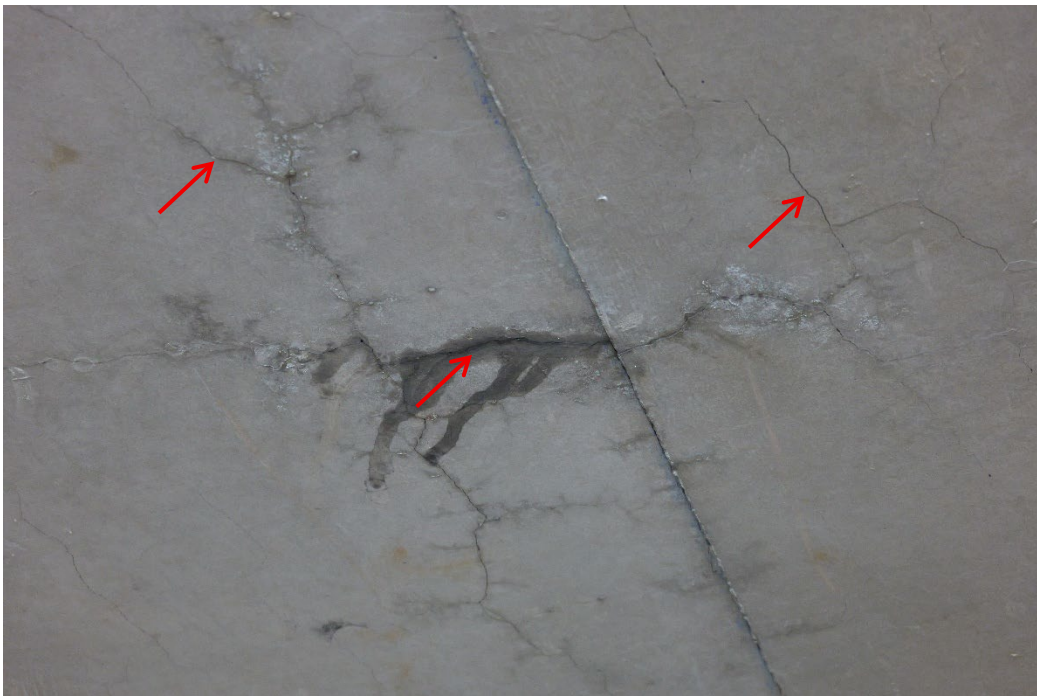
**Photographs 33 and 34** show **Location 17**, where crisscrossing slab cracks, active leakage, and efflorescence were visible. Leakage from the slab was dripping onto the light fixture, causing corrosion and creating an unsafe condition.

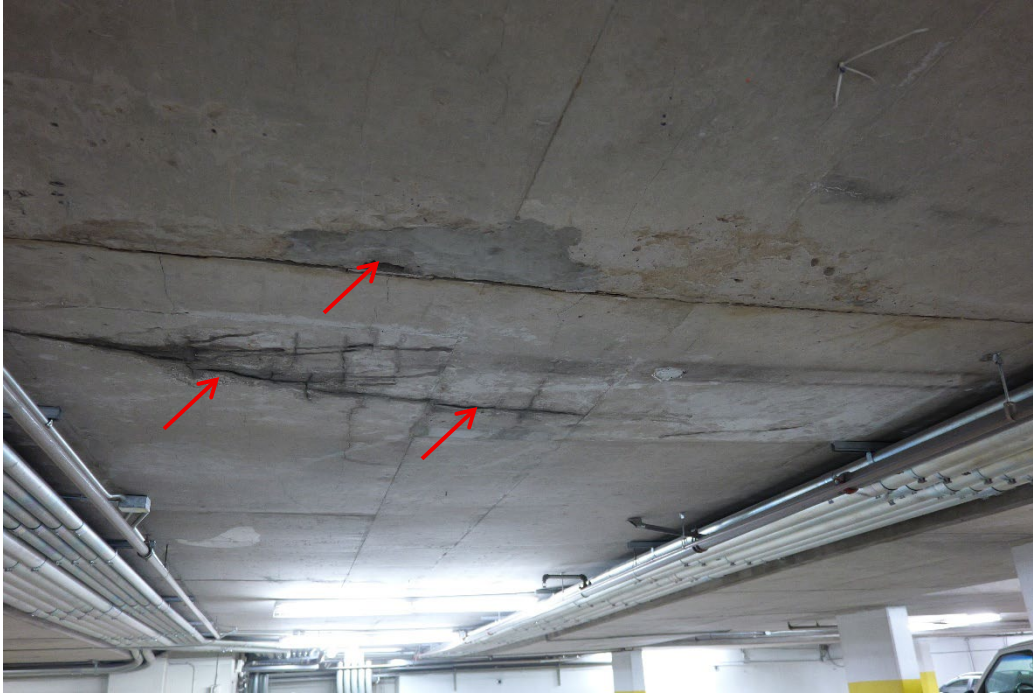
**Photographs 35 and 36** show **Location 18**, where crisscrossing slab cracks, active leakage, and efflorescence were visible. Efflorescence was also present on the floor slab.

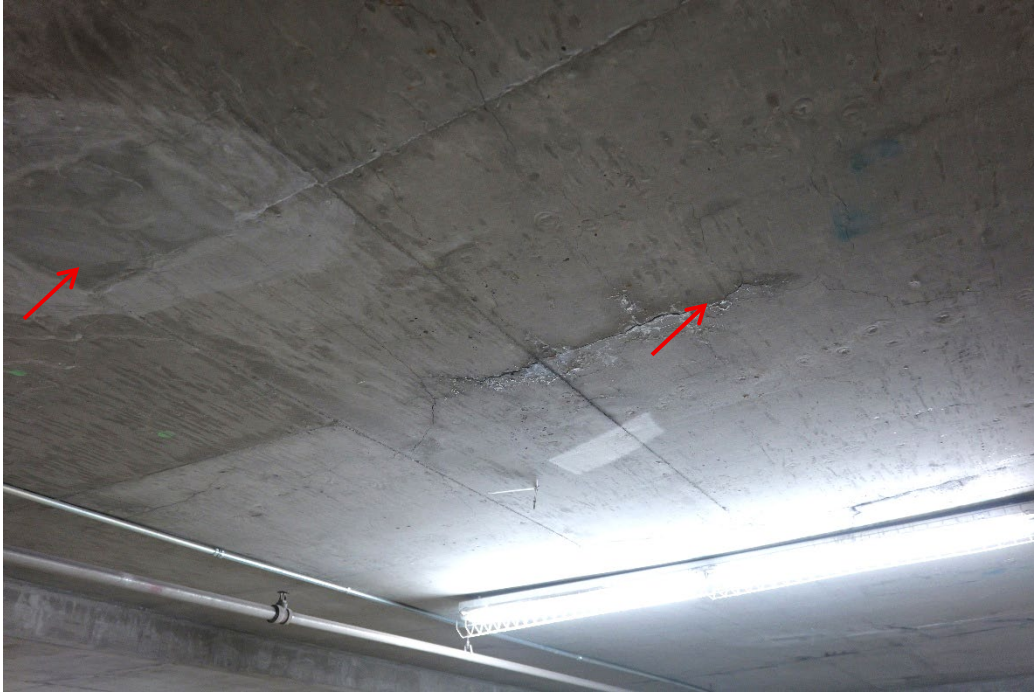
**Photographs 37 and 38** show **Location 19**, where crisscrossing cracking and efflorescence are visible on the soffit of the elevated slab. The slab-on-grade exhibited a crazing crack pattern.

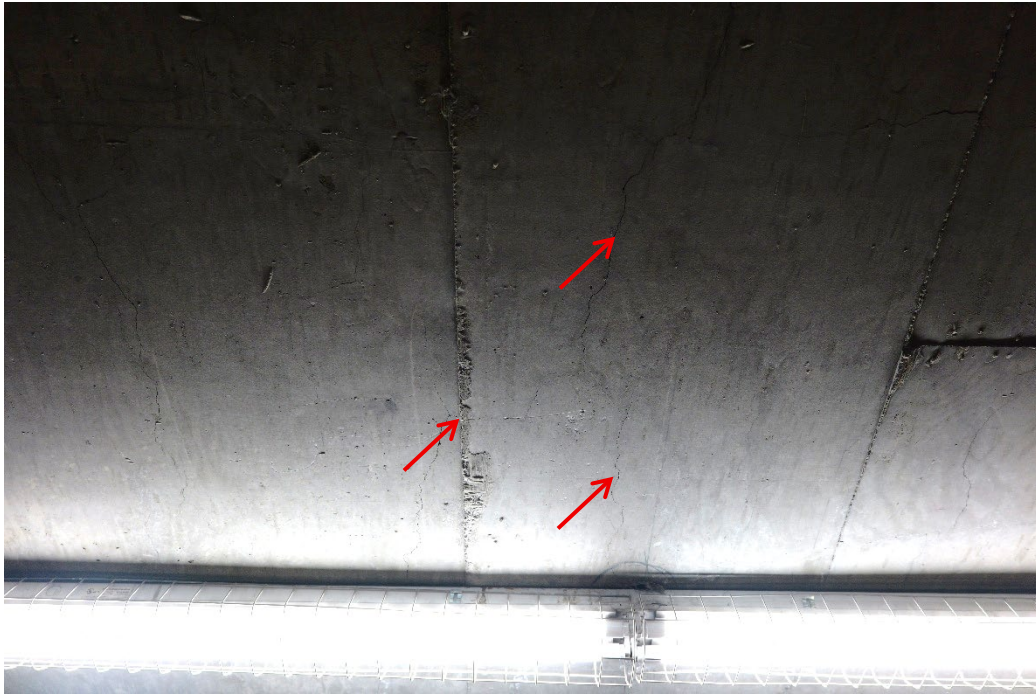
Photographs 39 and 40 show **Location 20**, where slab cracking and heavy efflorescence were visible.

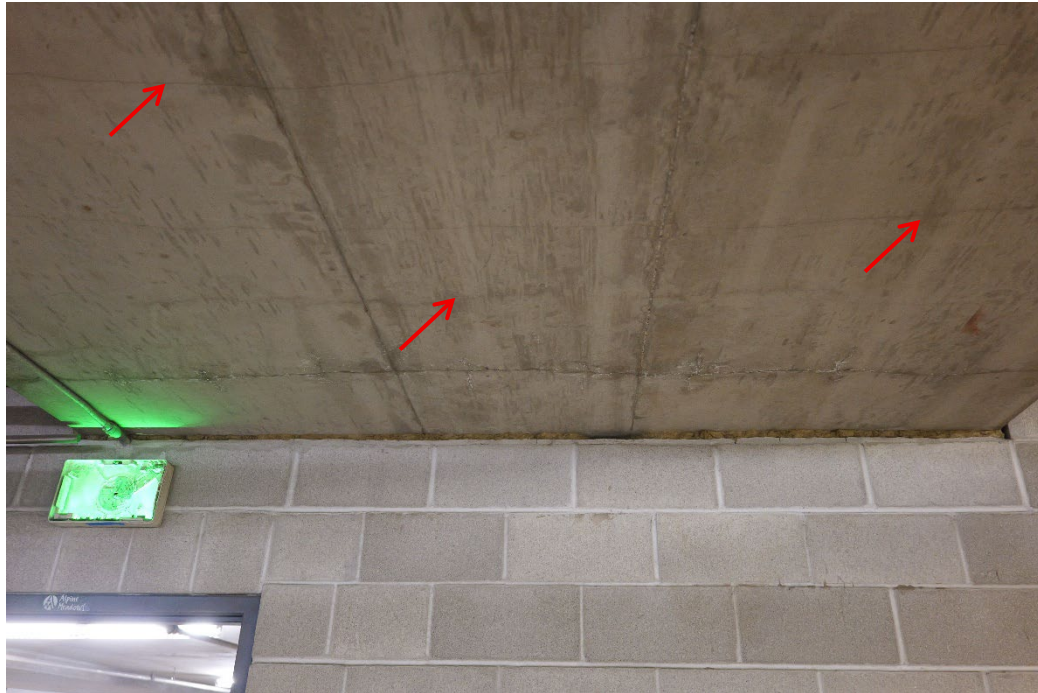
**Photographs 41 and 42** show **Location 21**, where slab cracking and heavy efflorescence were visible.

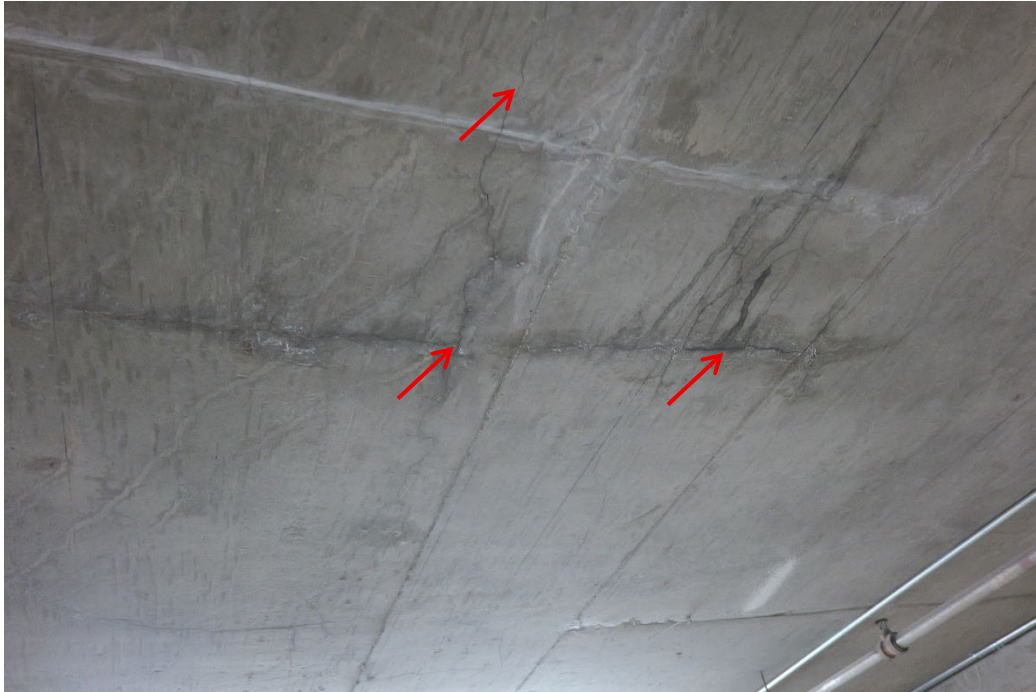
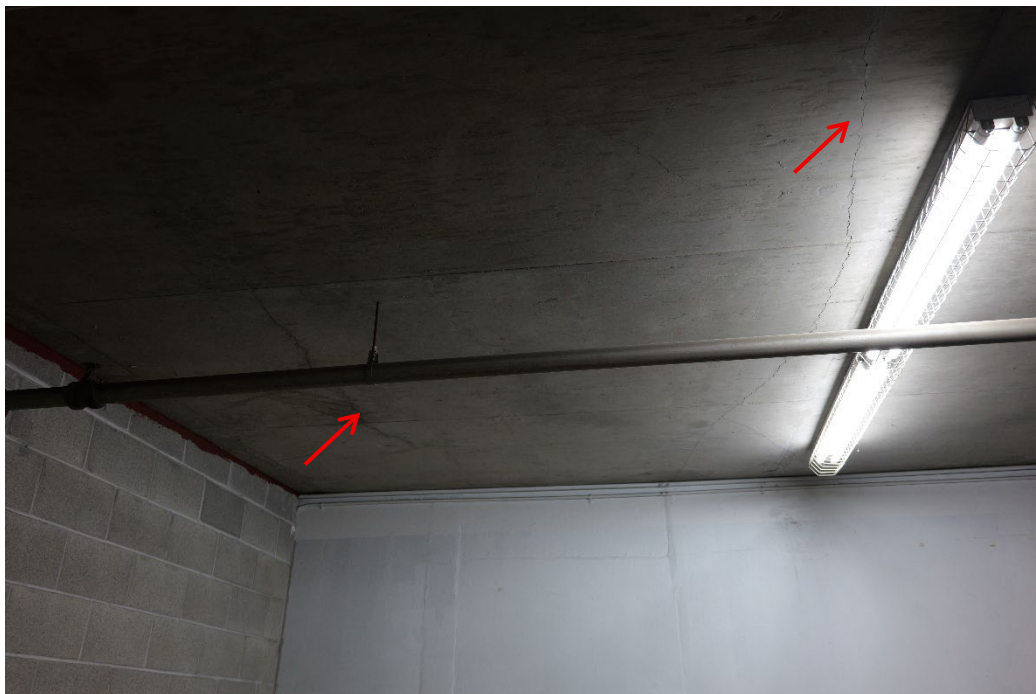
**Photographs 43 and 44 show Location 22, where slab cracking and efflorescence were visible.**

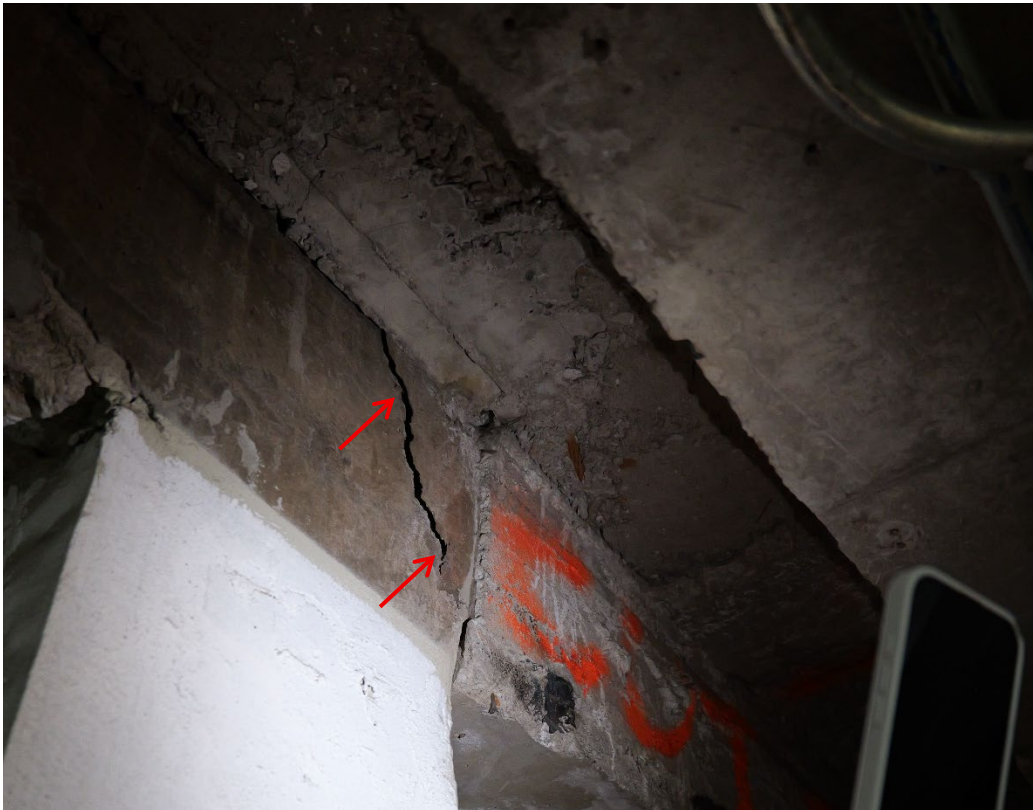
- a) The beam exhibits exposed reinforcement that appears to be associated with improper construction and/or vehicular impact, along with subsequent patch repairs. A concrete spall was also visible above the column and may indicate an underlying crack. A detailed engineering review is recommended.

**Photographs 45 and 46** show **Location 23**, where one beam exhibits exposed reinforcement that appears to be associated with improper construction and/or vehicular impact, along with subsequent patch repairs. A concrete spall is also visible above the column and may indicate an underlying crack

that warrants further evaluation.

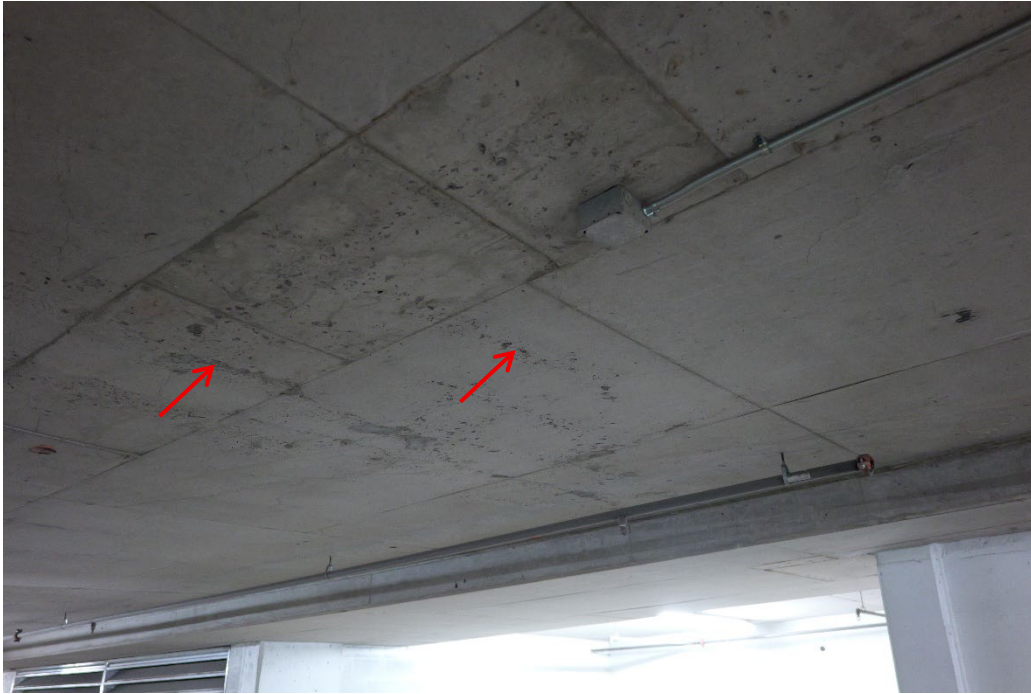
**Photographs 47 and 48 show Location 24, where slab honeycombing is visible, and reinforcement was exposed in the slab-on-grade.**

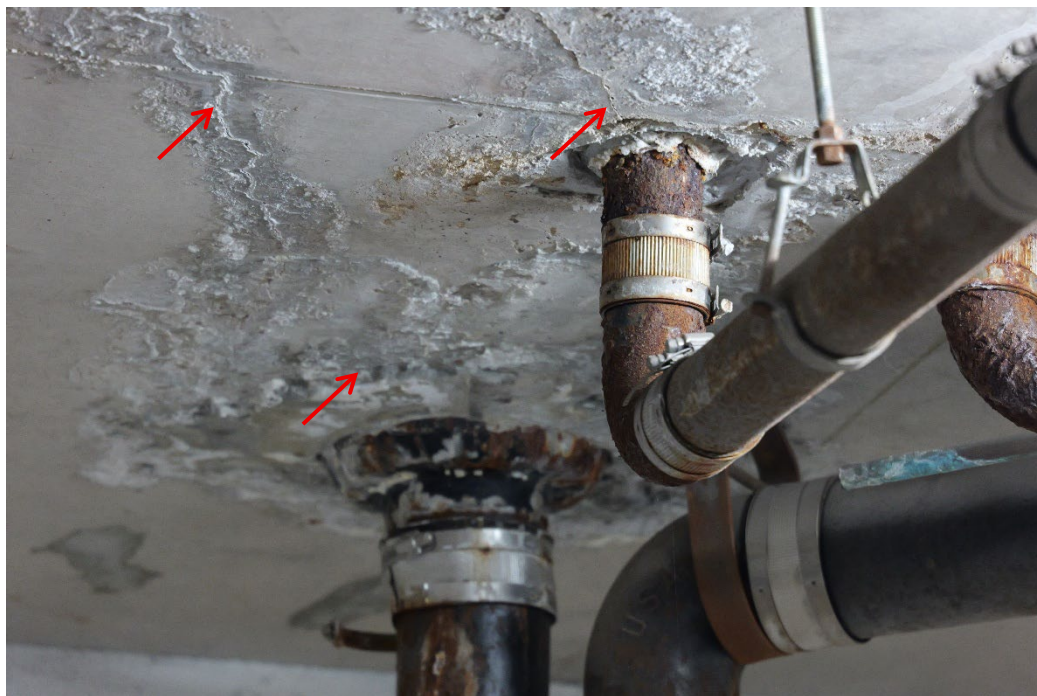
**Photographs 49 and 50** show **Location 25**, where the gap at the ends of the fixtures suggested slab sag at midspan. This condition may have originated during construction or may reflect subsequent deflection. Locations where pipes penetrate the slab exhibit heavy efflorescence, and the leaking plumbing connections should be addressed.

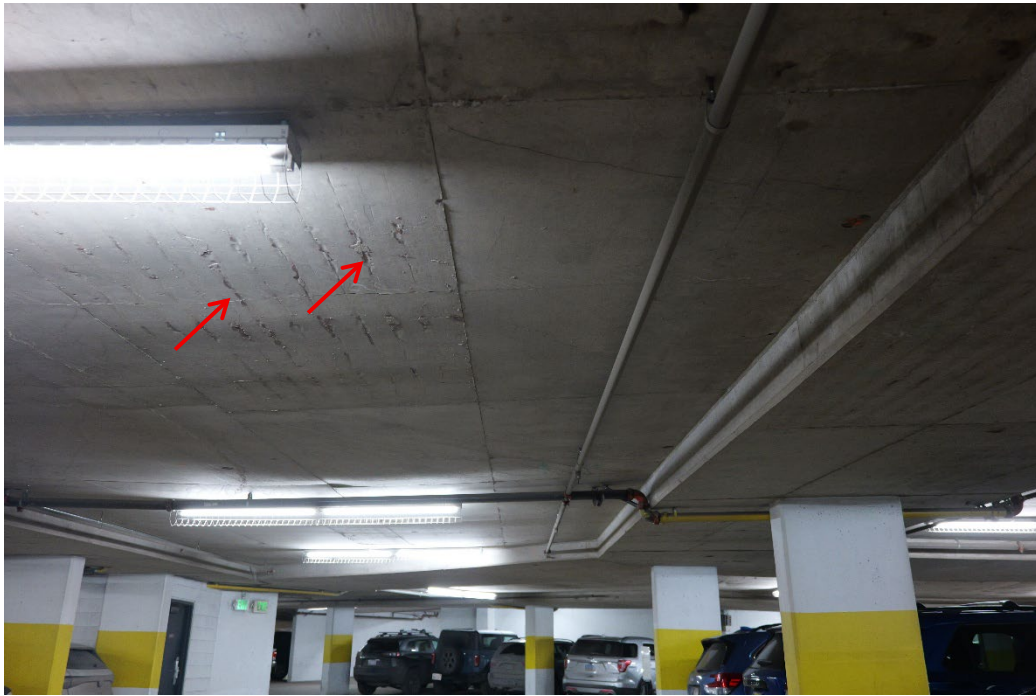
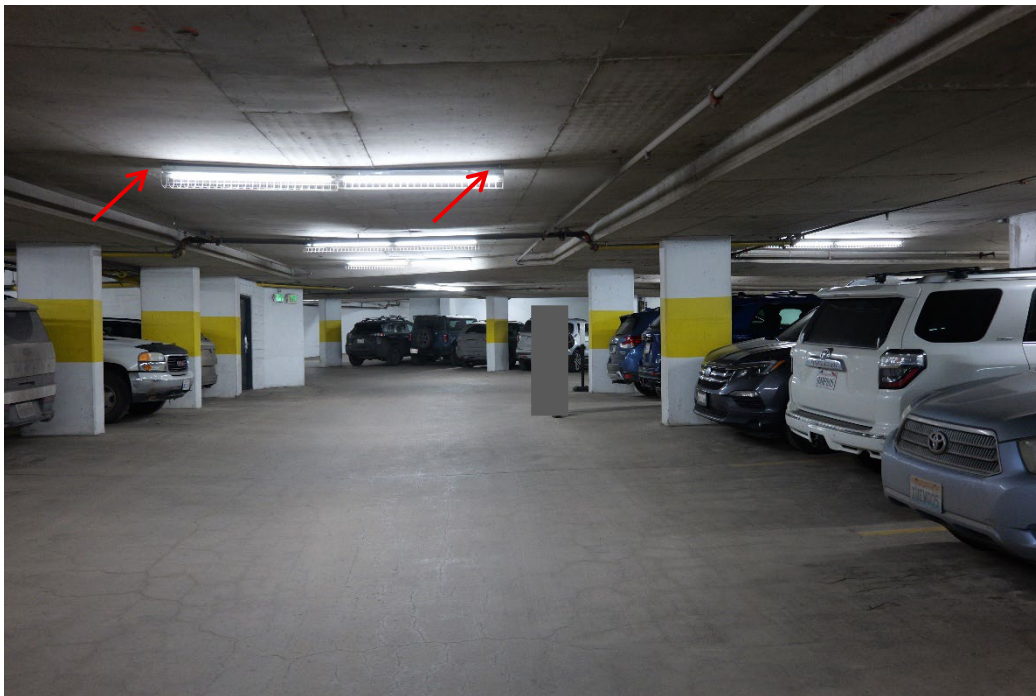
**Photographs 51 and 52** show **Location 26**, where serrations are visible on the slab soffit, suggesting possible cracking along the slab reinforcement. Possible slab sagging was also observed.

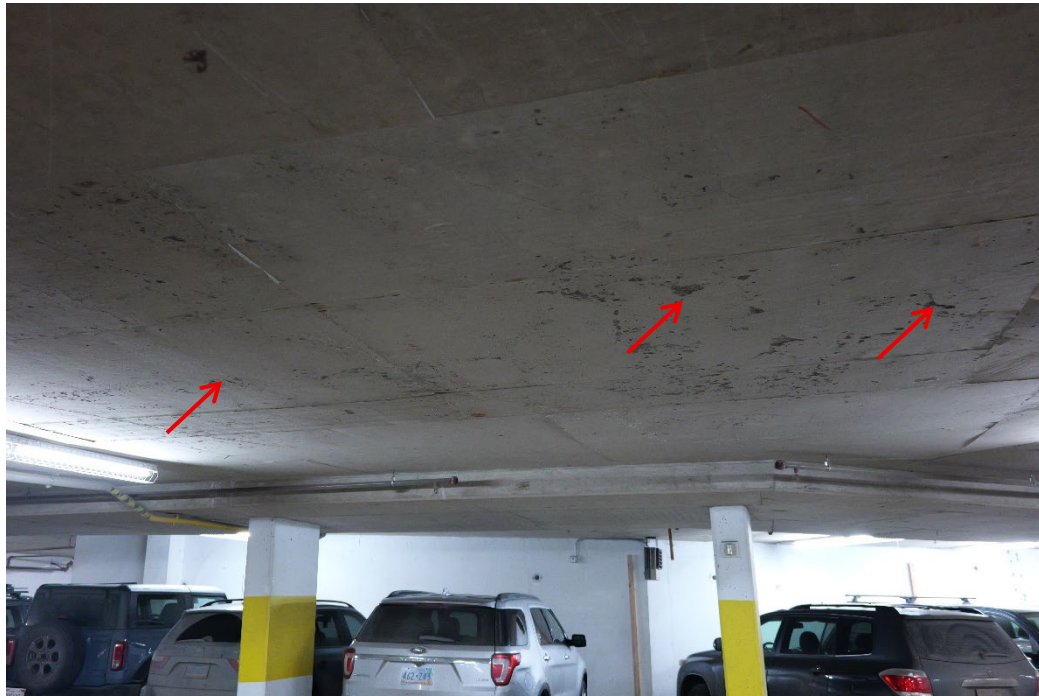
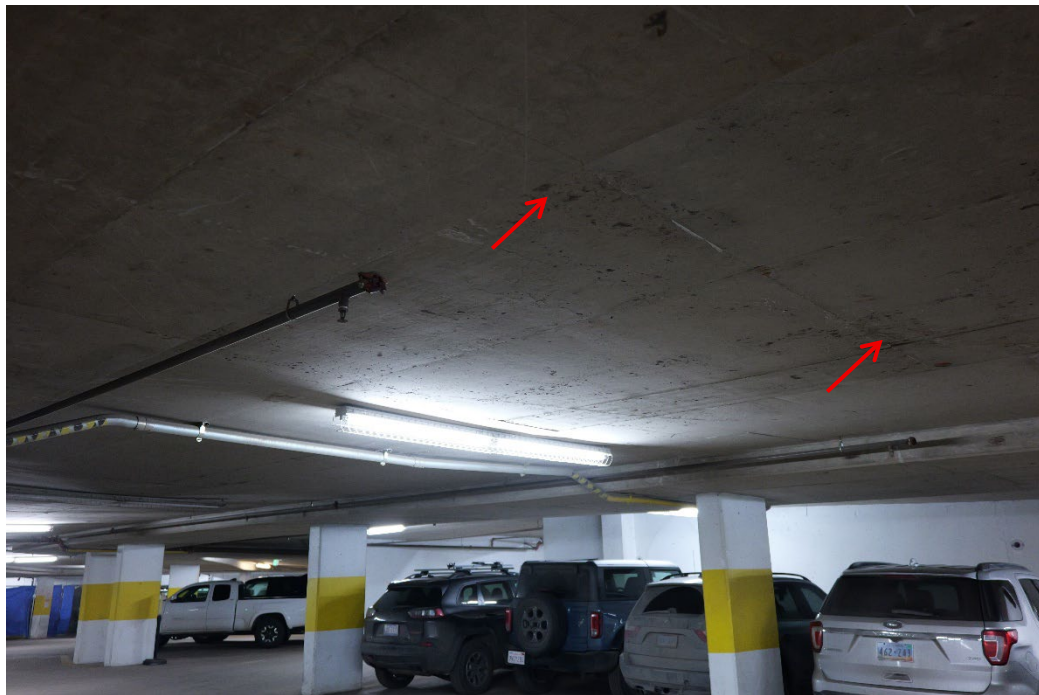
**Photographs 53 and 54** show **Location 27**, where concrete honeycombing was visible on the slab soffit.

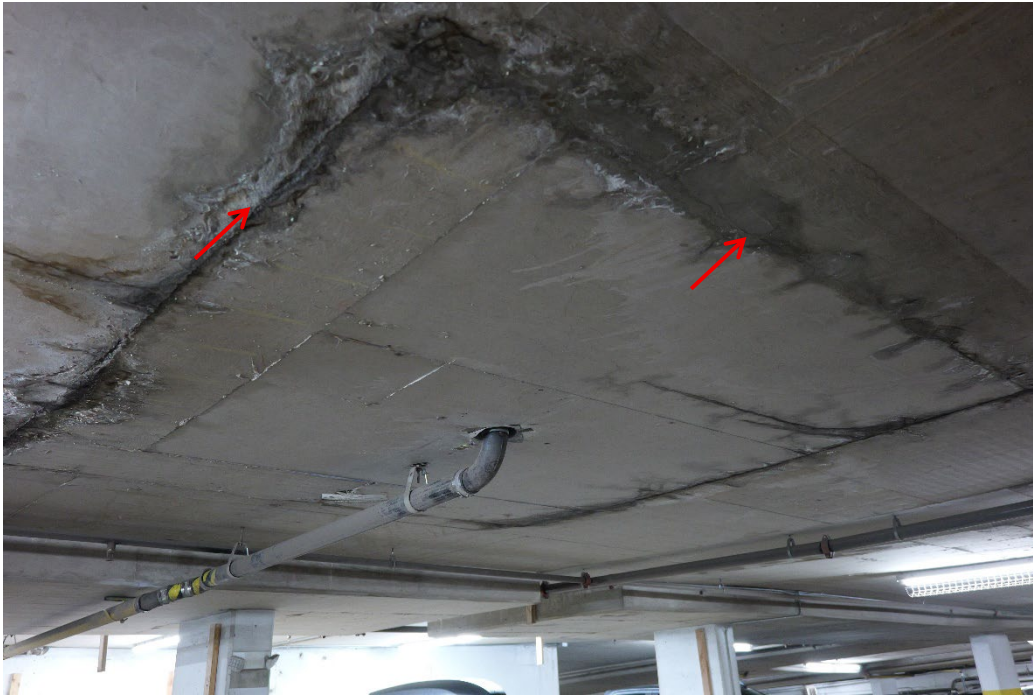
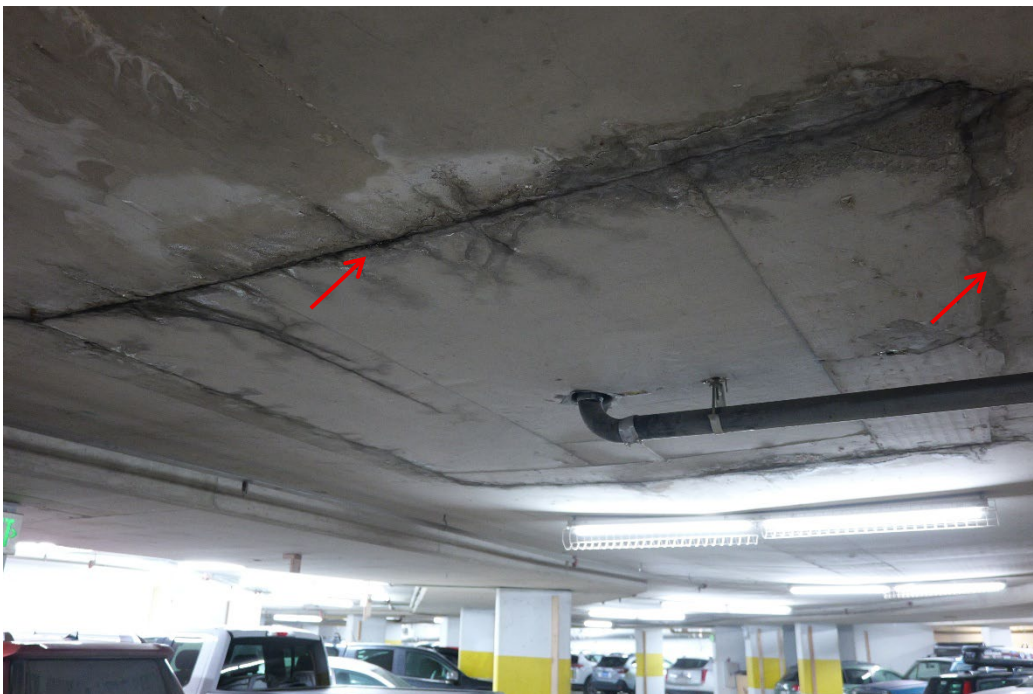
**Photographs 55 and 56 show Location 28, Water leak along slab joints.**

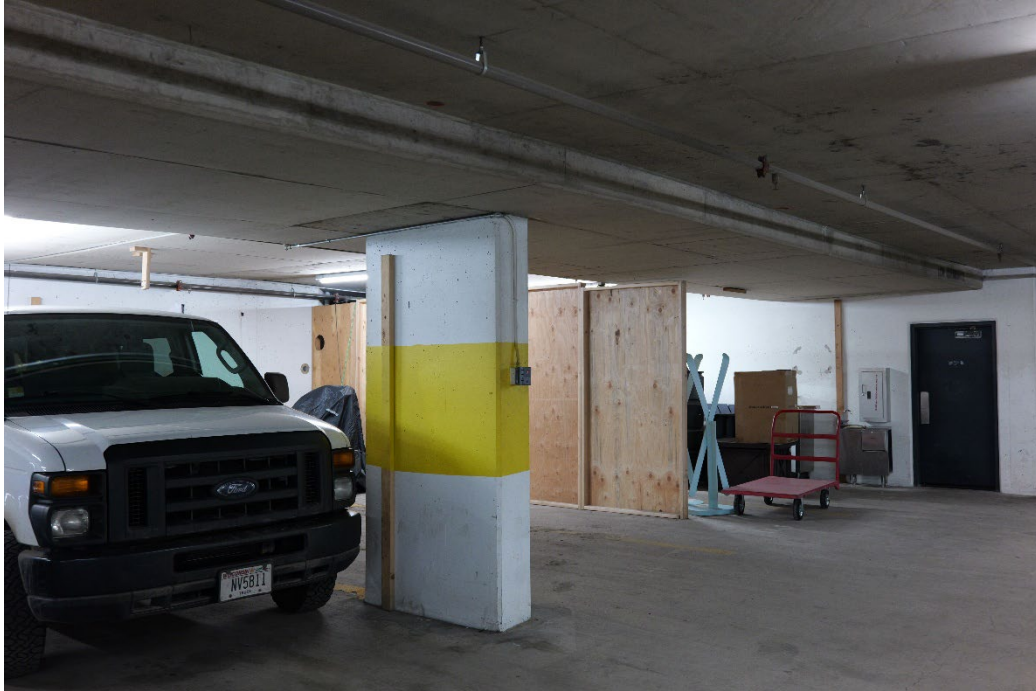
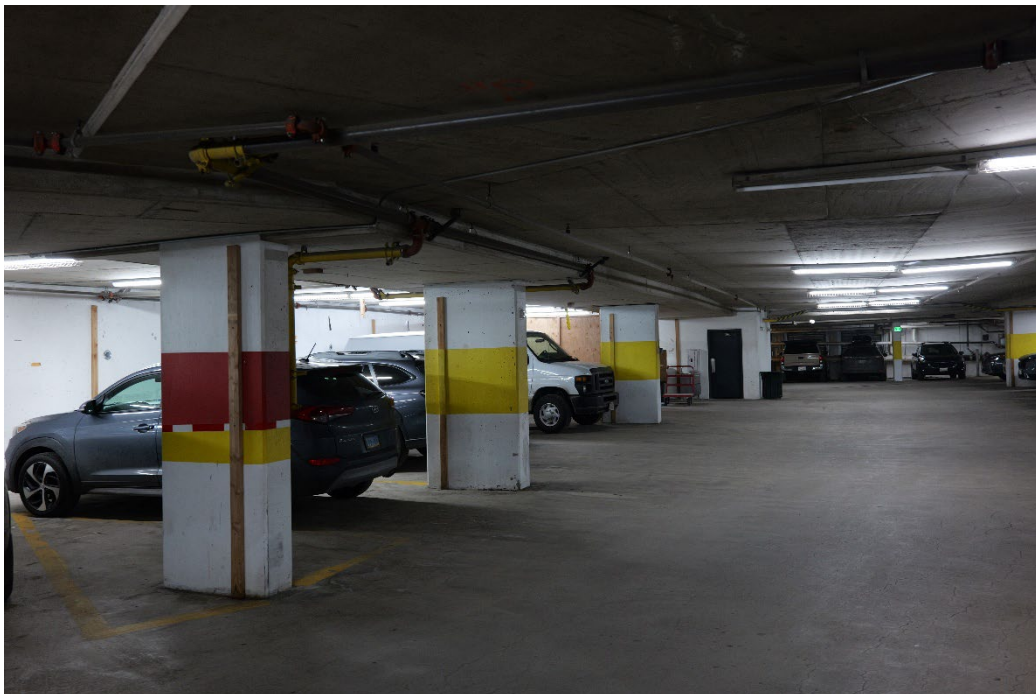
**Photographs 57 and 58 show Location 29, where no major anomalies were observed.**

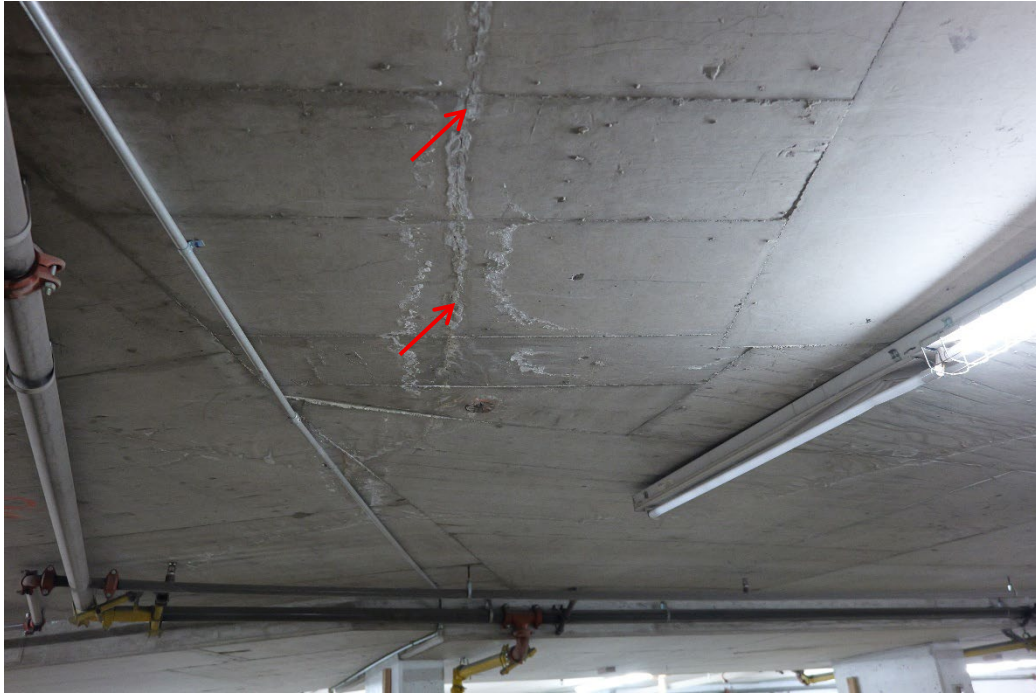
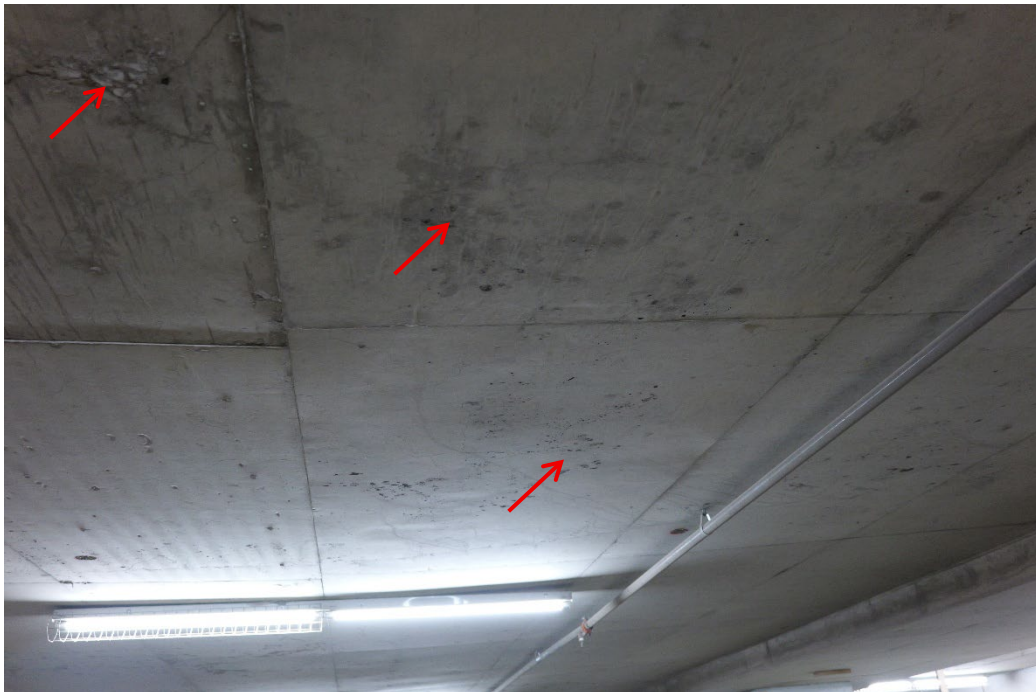
Photographs 59 and 60 show **Location 30**, where cracking and efflorescence were visible, together with localized slab honeycombing.

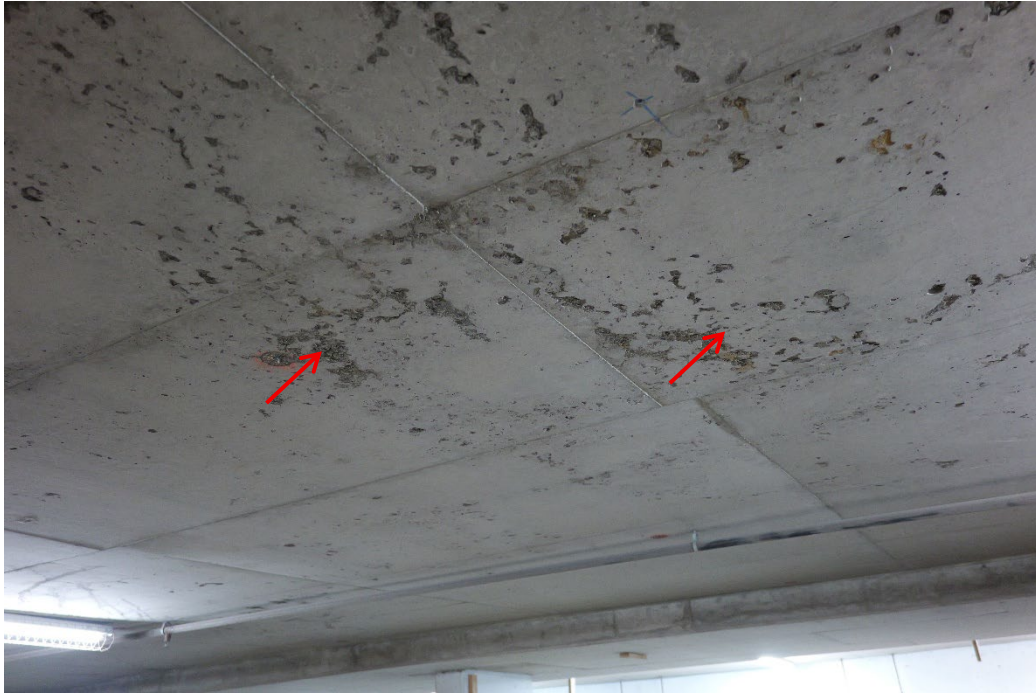
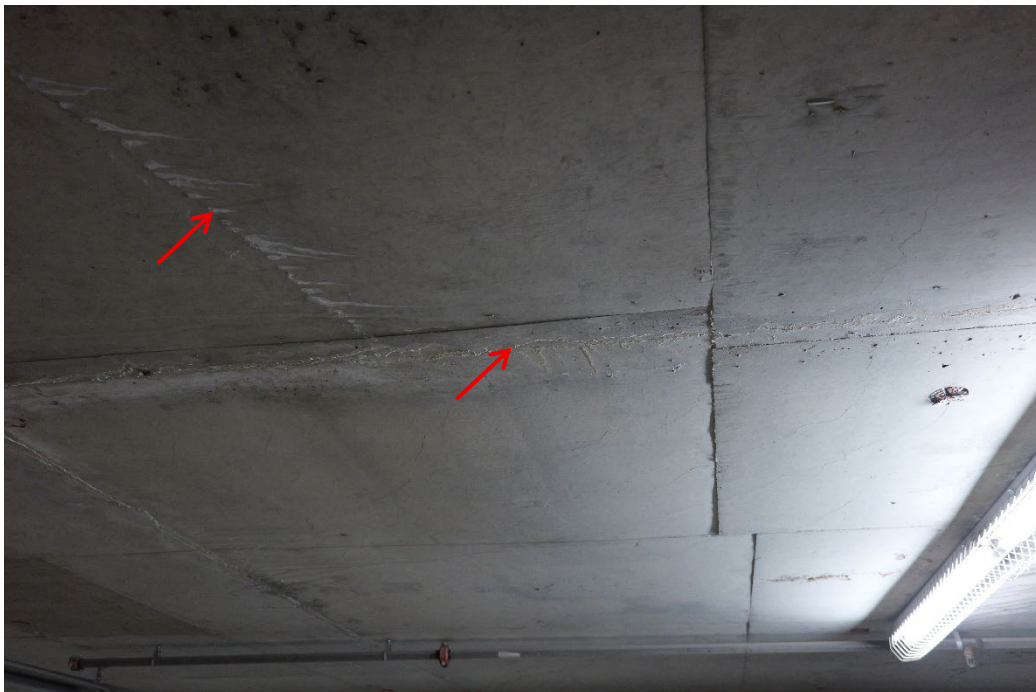
**Photographs 61 and 62** show **Location 31**, where cracking and efflorescence were visible, together with localized slab honeycombing.

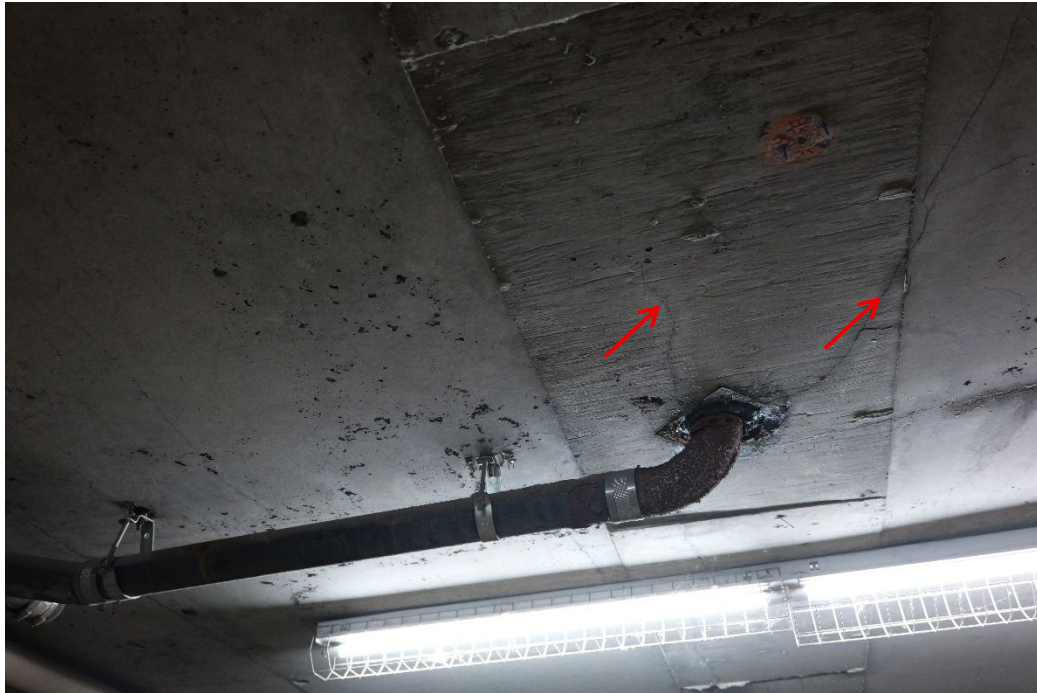
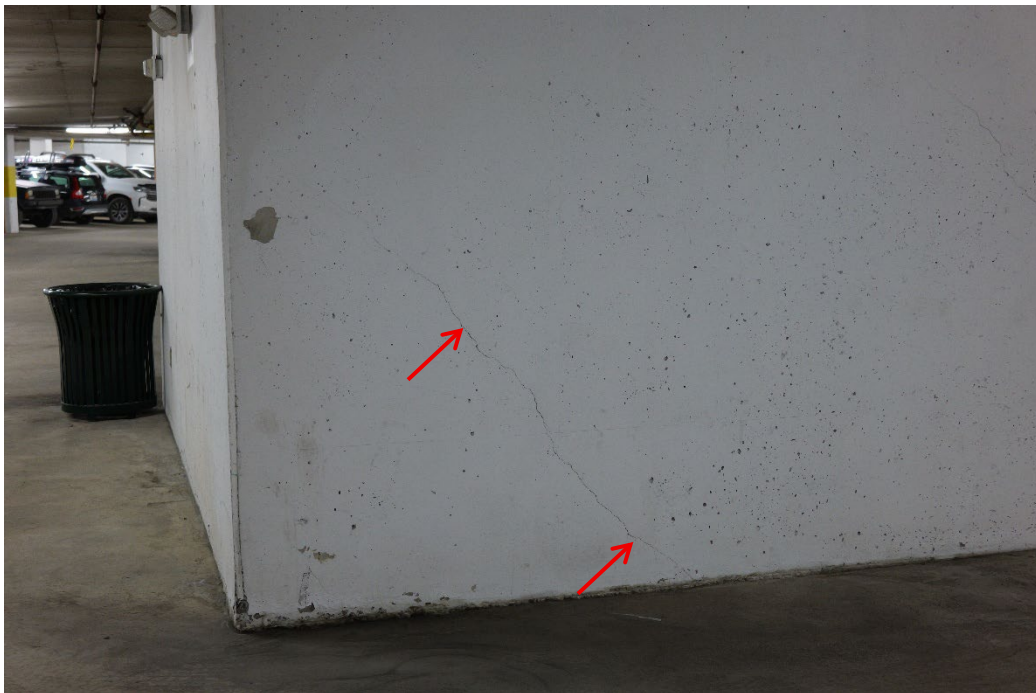
**Photographs 63 and 64** show **Location 32**, where cracks radiate from pipe openings and localized slab honeycombing is visible. A diagonal crack was also present in the staircase wall.

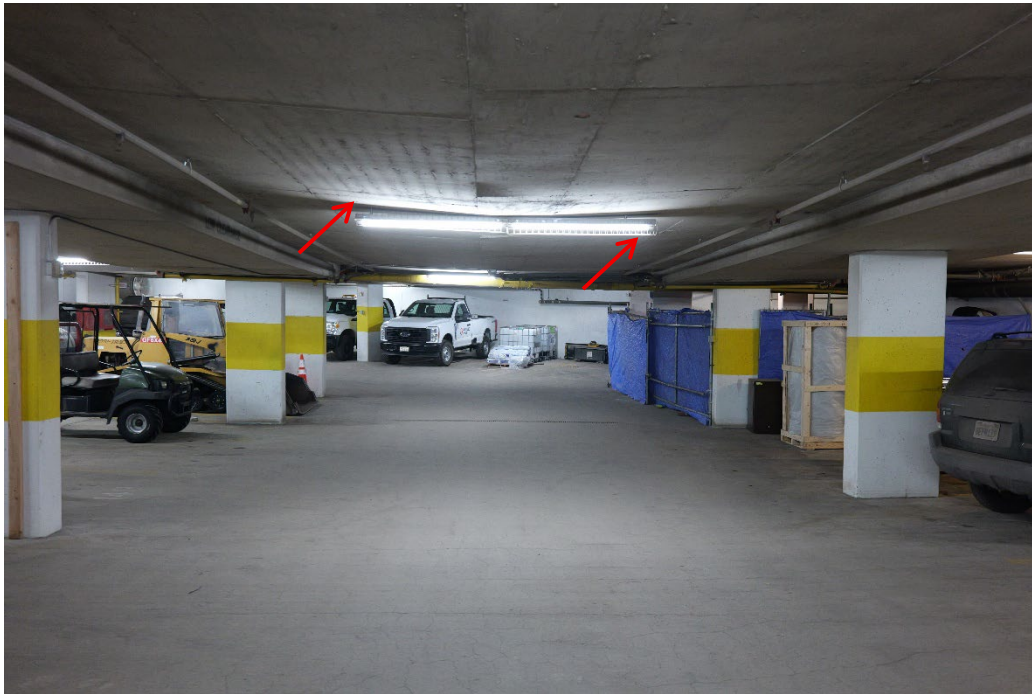
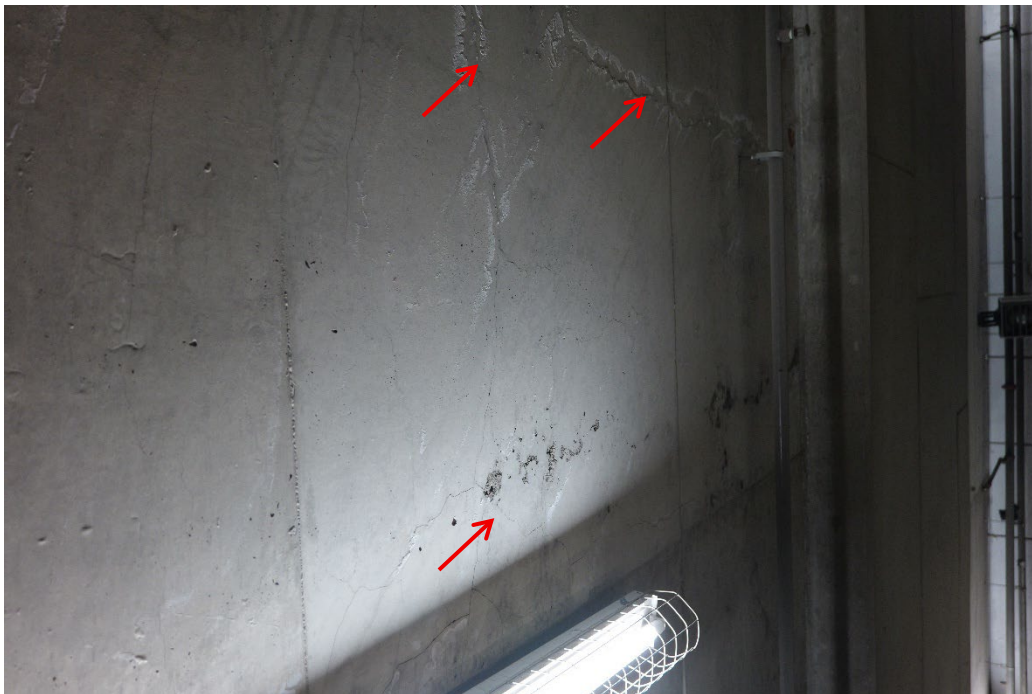
**Photographs 65 and 66** show **Location 33**, where apparent slab sagging was visible at midspan. This condition may have originated during construction or developed subsequently. Cracking and efflorescence are also visible on the slab soffit.

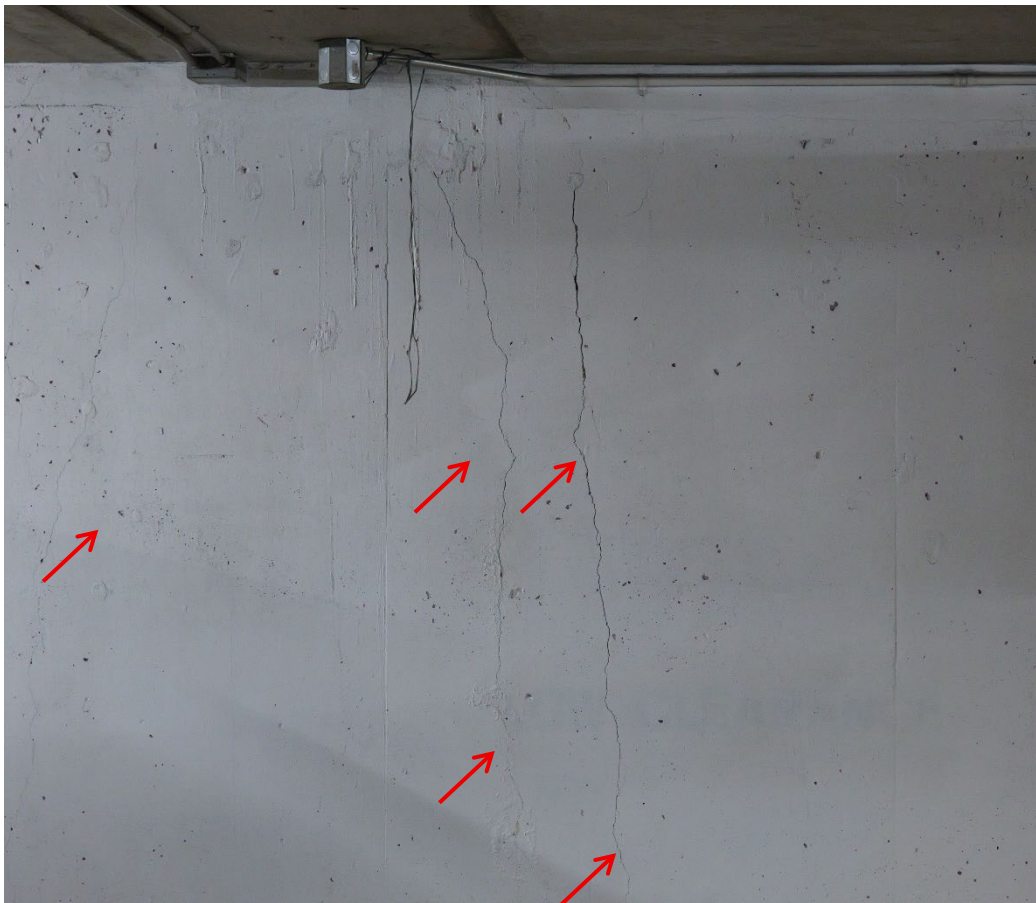
Photographs 69 and 70 show **Location 35**, where cracking was visible in the retaining wall.

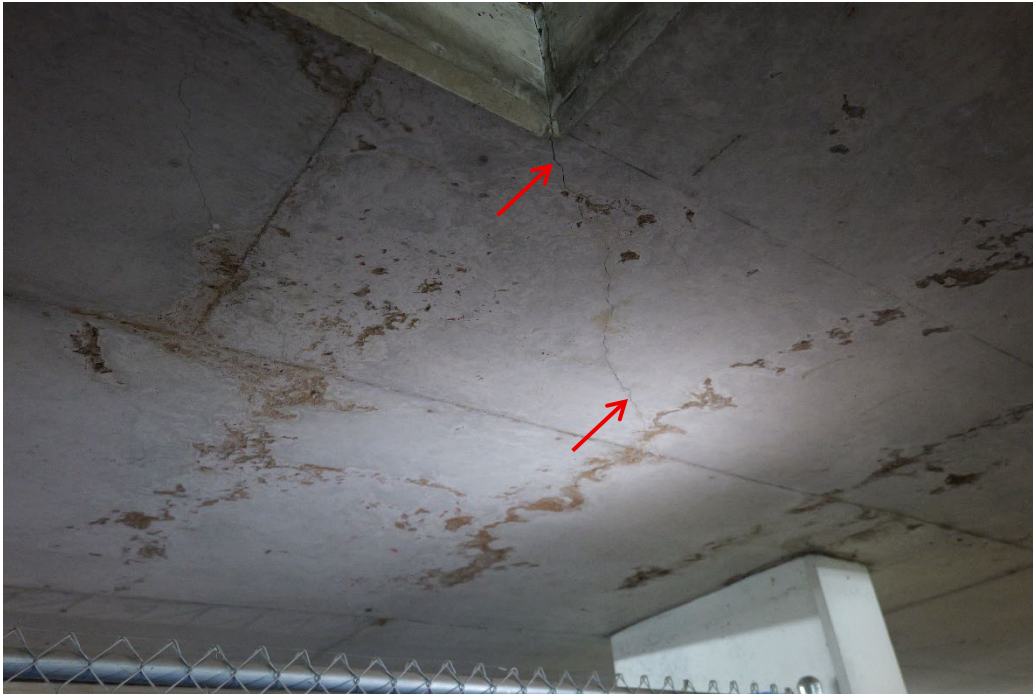
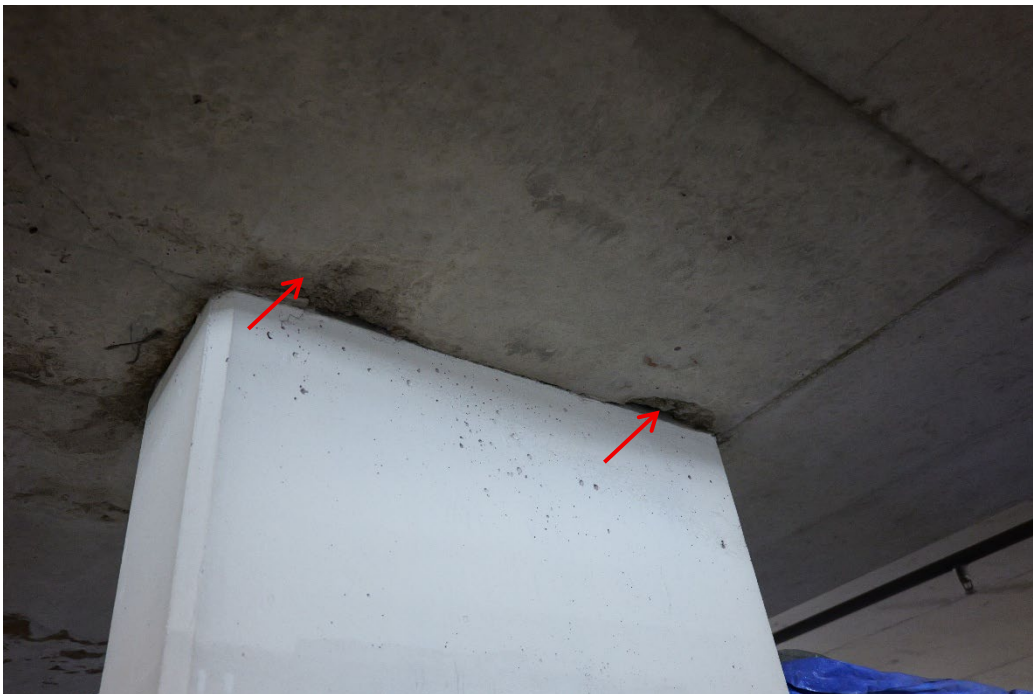
**Photographs 71 and 72** show **Location 36**, where cracking was visible at the band beam junction. Honeycombing was present at the slab-column junction, and residue from formwork panels was visible on the soffit.
