## **Visual Inspection Report**

### **The P2-level Parking Garage Under Building 5**

Project: The Village at Palisades, Olympic Valley, CA 94146

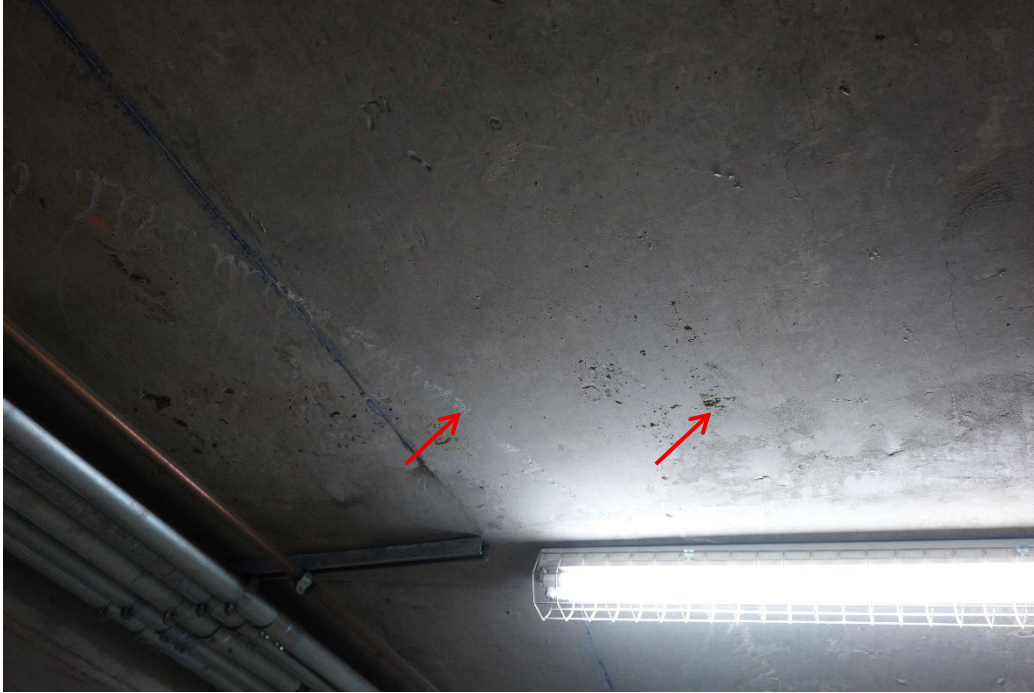
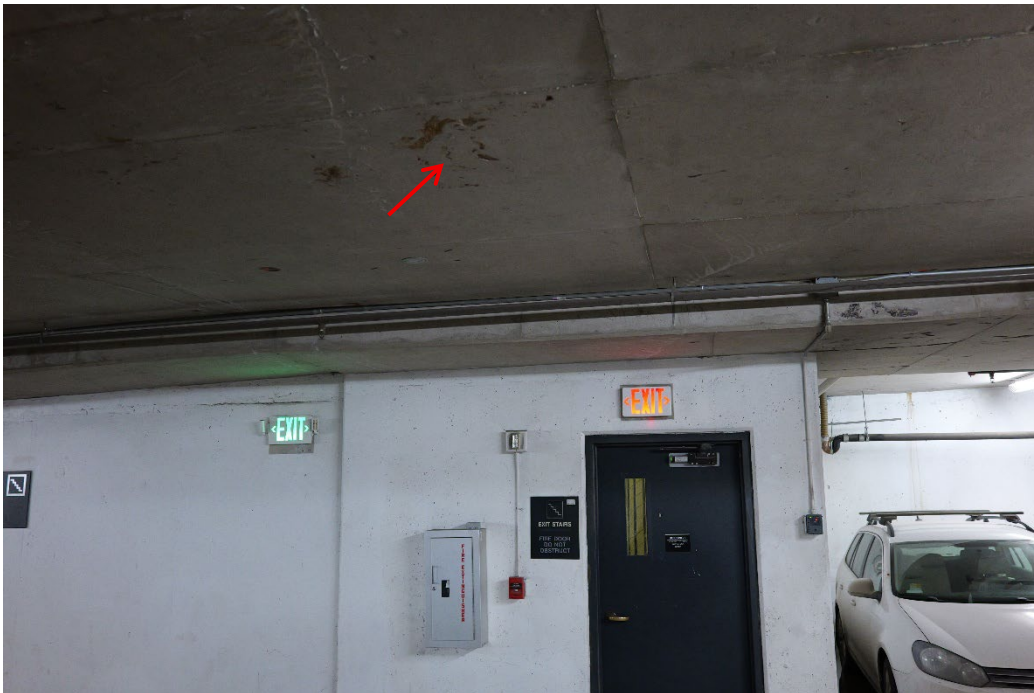
Photographs 73 and 74 show **Location 37**, where minor honeycombing was visible.

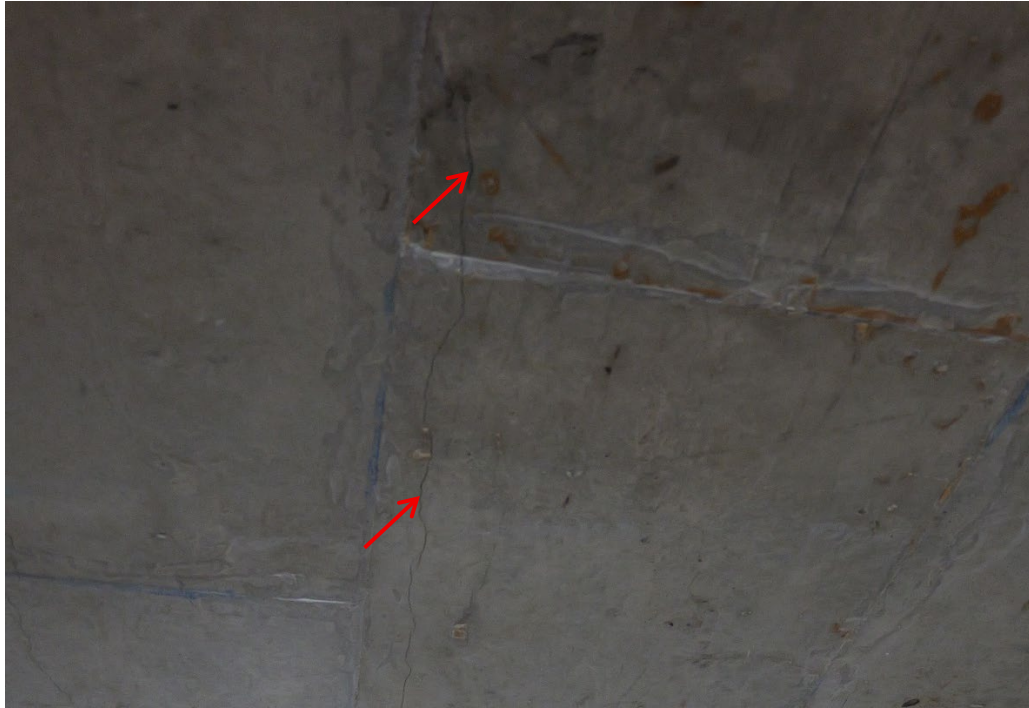
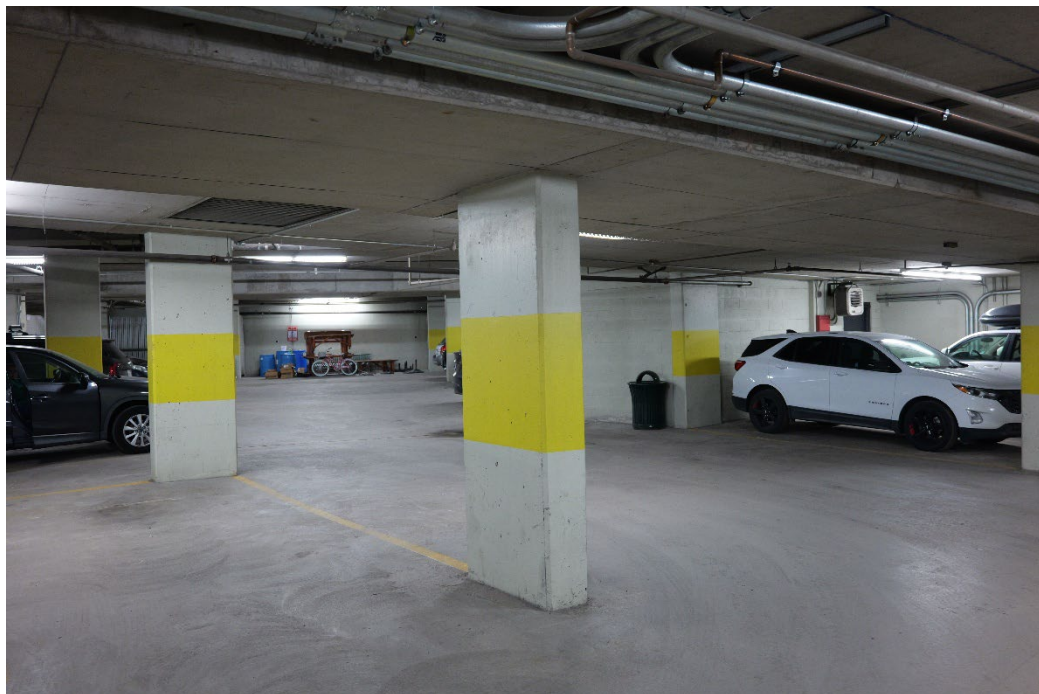
**Photographs 75 and 76 show Location 38, where cracking was visible on the soffit. No honeycombing was observed.**

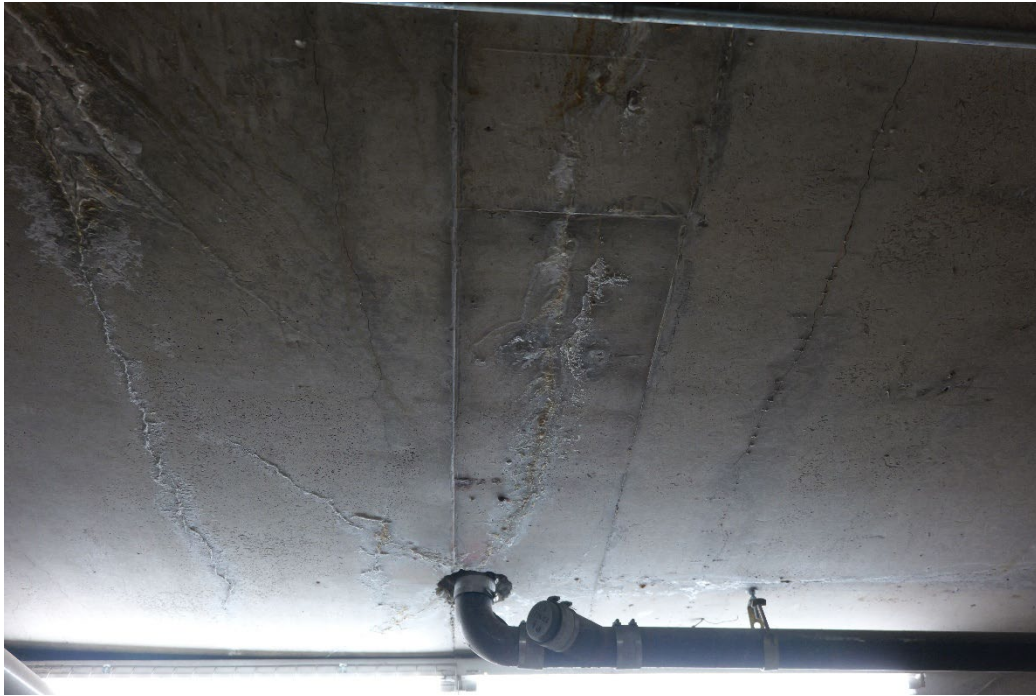
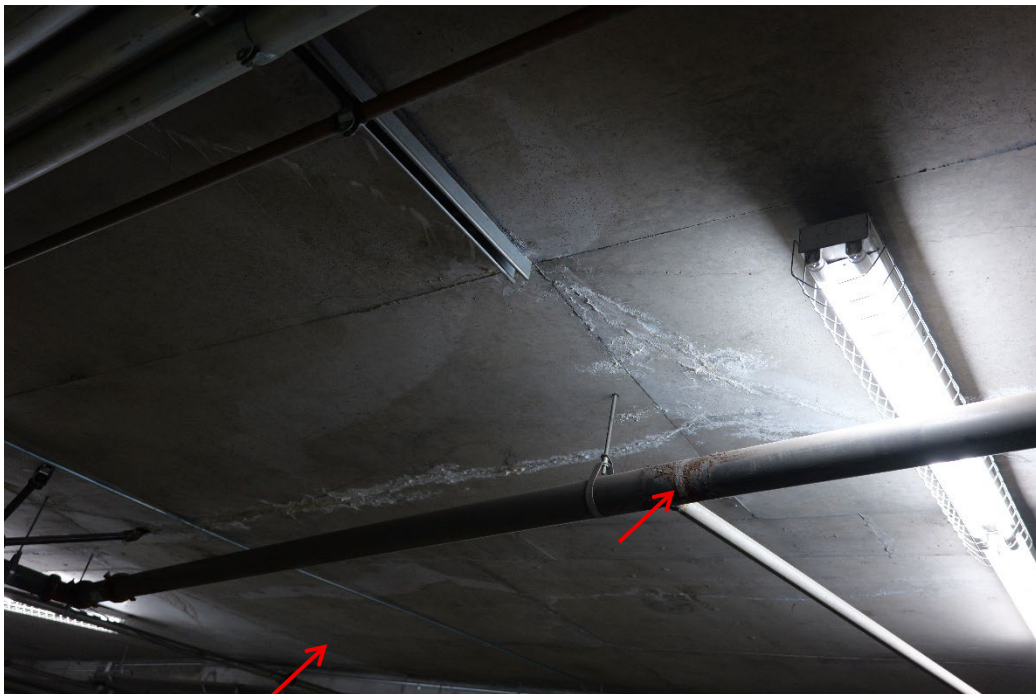
Photographs 77 and 78 show **Location 39**, where cracking and efflorescence are visible on the soffit.

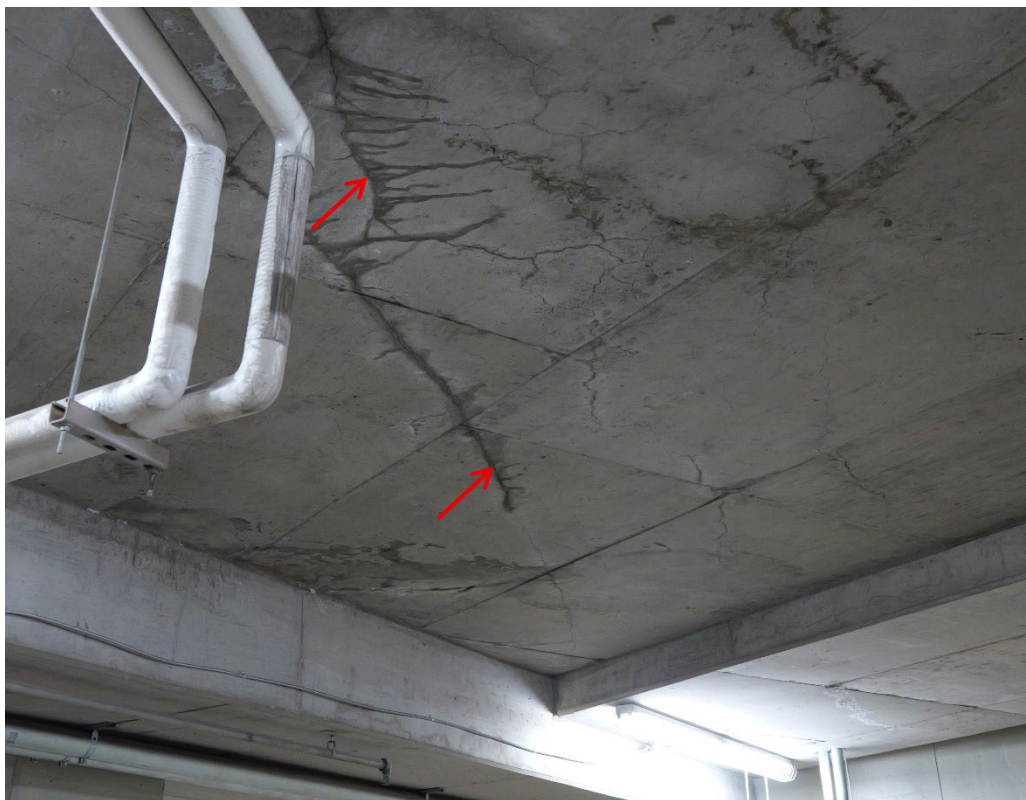
Photographs 79 and 80 show **Location 40**, where cracking and efflorescence were visible on the soffit of the elevated slab.

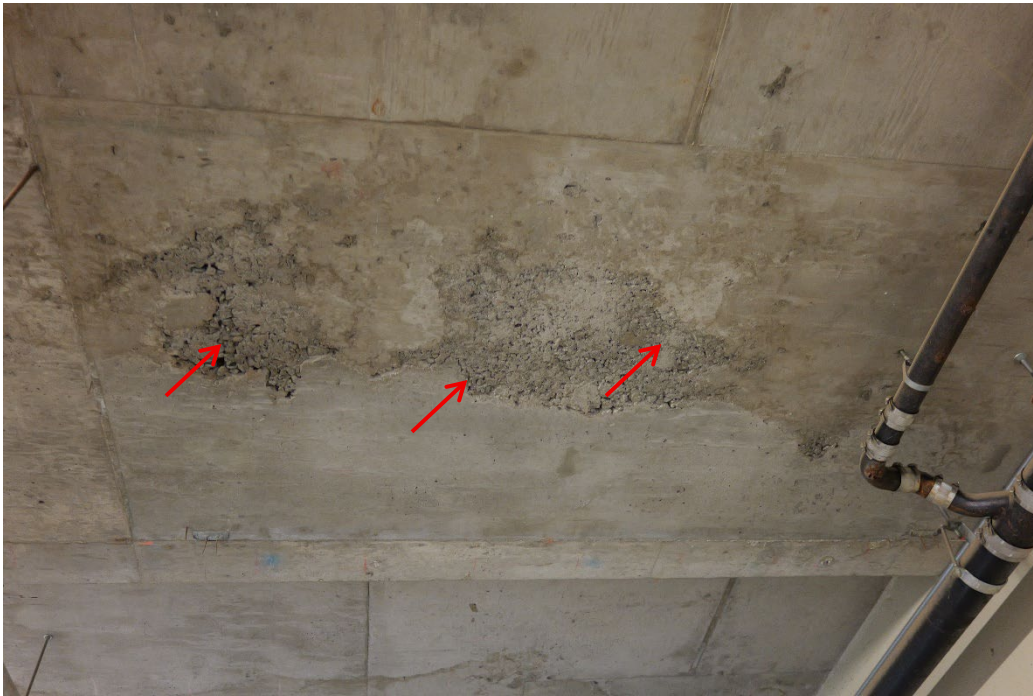
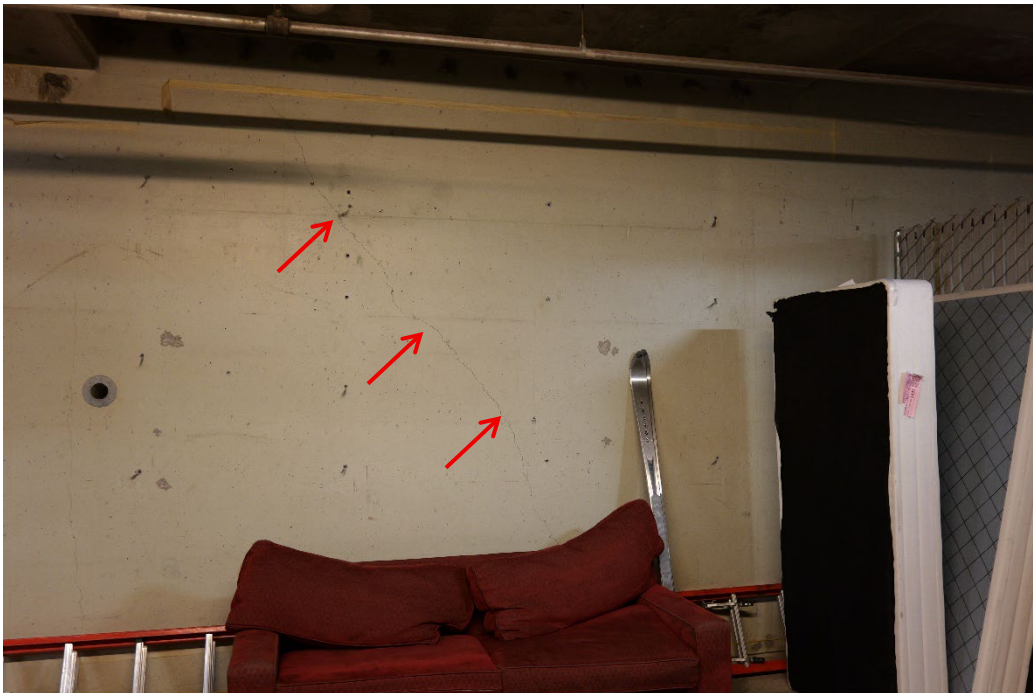
Photographs 81 and 82 show **Location 41**, where honeycombing was visible on the soffit, and cracking was visible on the wall. 22 station
