## **Visual Inspection Report**

### **The P2-level Parking Garage Under Building 5**

Project: The Village at Palisades, Olympic Valley, CA 94146

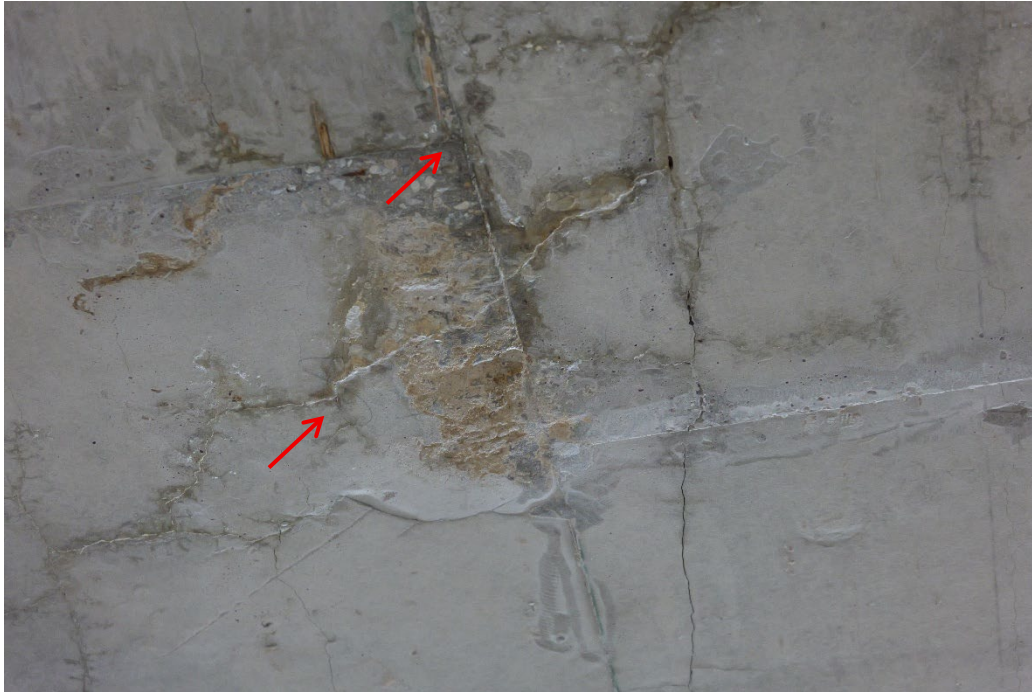
**Photographs 19 and 20** show **Location 10**, where parallel slab cracking and efflorescence are visible. A gap at the end of the light fixture suggests possible slab sagging, warranting further

evaluation.

**2. Possible excessive Slab deflection (Location #10)**

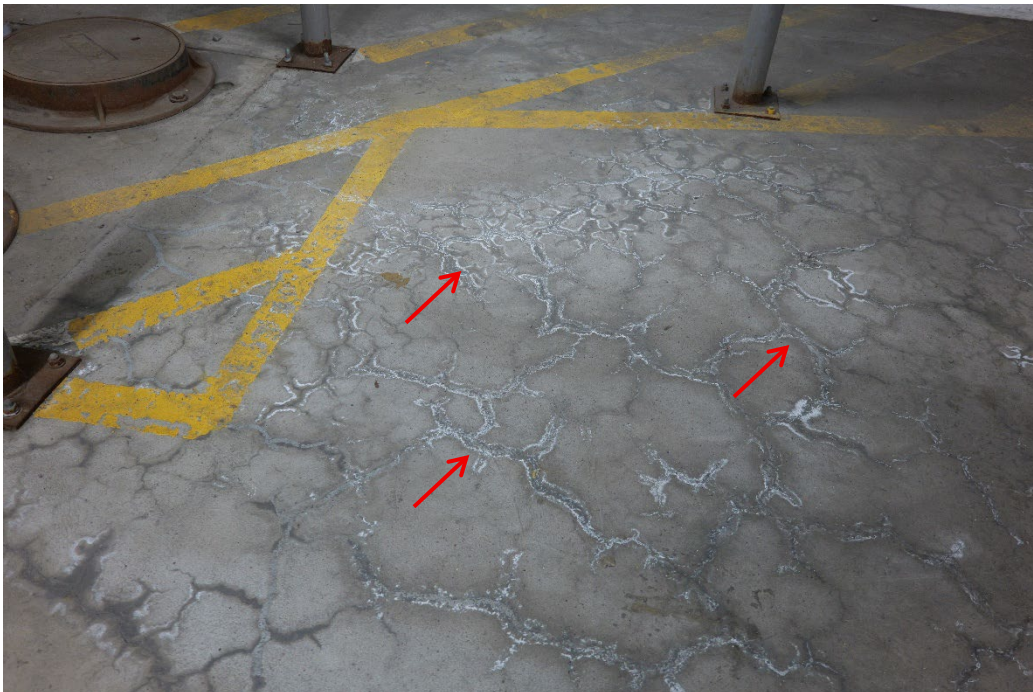
**Photographs 35 and 36** show **Location 18**, where crisscrossing slab cracks, active leakage, and efflorescence were visible. Efflorescence was also present on the floor slab.

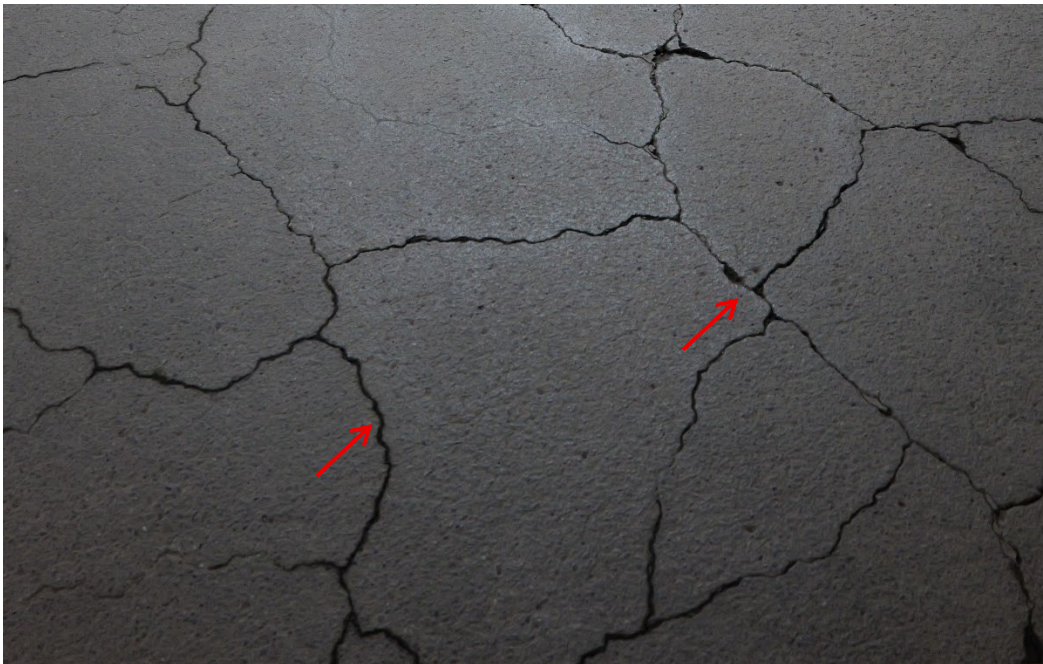
**Photographs 37 and 38** show **Location 19**, where crisscrossing cracking and efflorescence are visible on the soffit of the elevated slab. The slab-on-grade exhibited a crazing crack pattern.

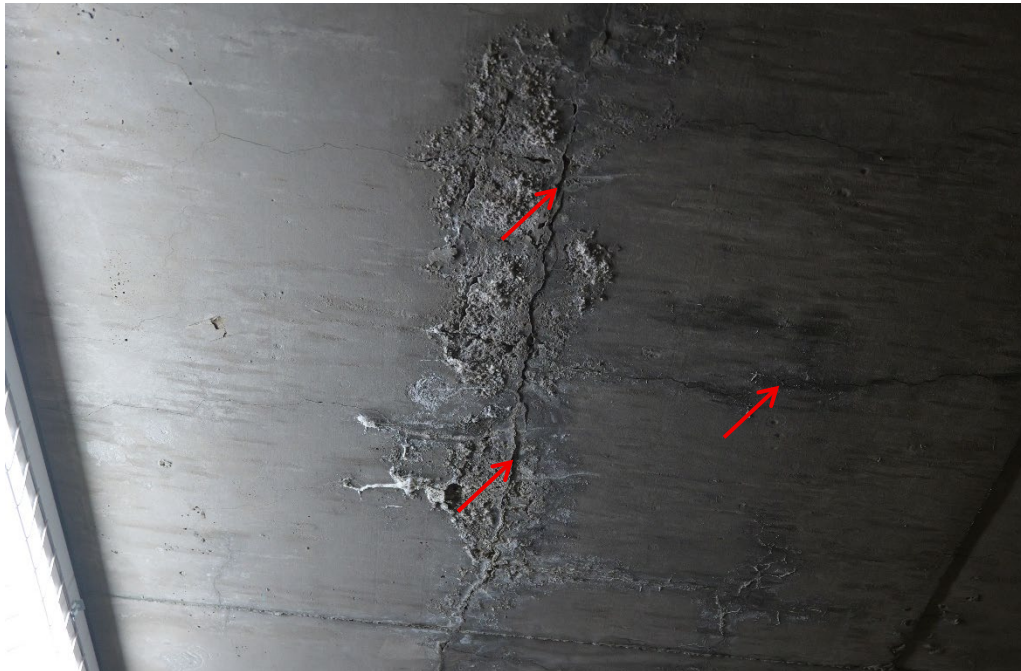
Photographs 39 and 40 show **Location 20**, where slab cracking and heavy efflorescence were visible.

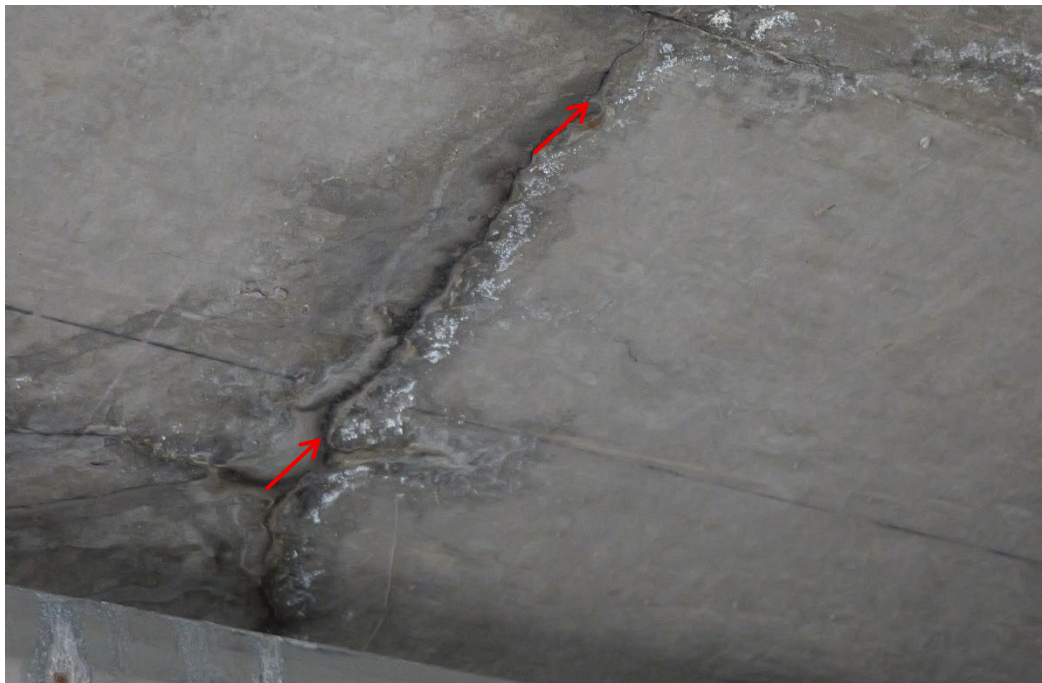
**Photographs 41 and 42** show **Location 21**, where slab cracking and heavy efflorescence were visible.

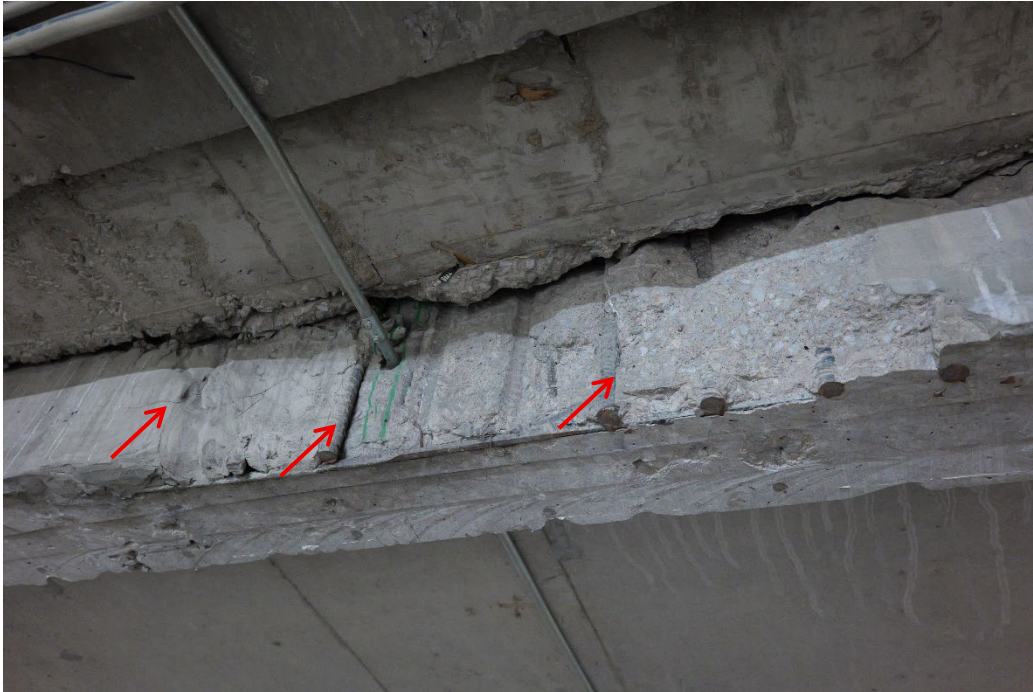
**Photographs 45 and 46** show **Location 23**, where one beam exhibits exposed reinforcement that appears to be associated with improper construction and/or vehicular impact, along with subsequent patch repairs. A concrete spall is also visible above the column and may indicate an underlying crack

that warrants further evaluation.

**3. Exposed Beam Reinforcement & Spalling (Location 23)**

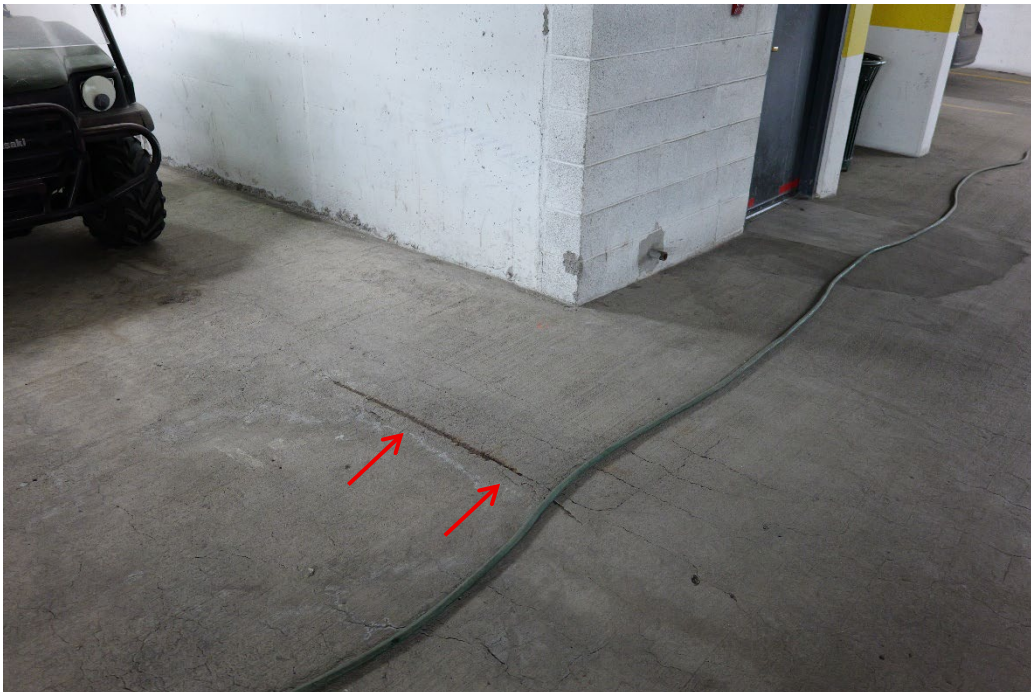
**Photographs 47 and 48 show Location 24, where slab honeycombing is visible, and reinforcement was exposed in the slab-on-grade.**

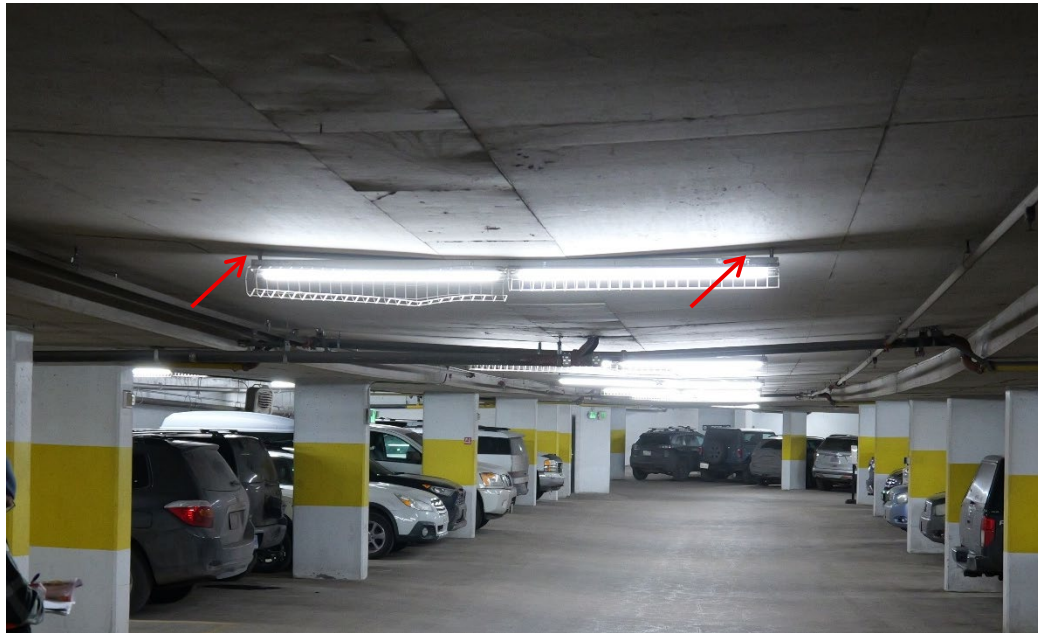
**Photographs 49 and 50** show **Location 25**, where the gap at the ends of the fixtures suggested slab sag at midspan. This condition may have originated during construction or may reflect subsequent deflection. Locations where pipes penetrate the slab exhibit heavy efflorescence, and the leaking plumbing connections should be addressed.

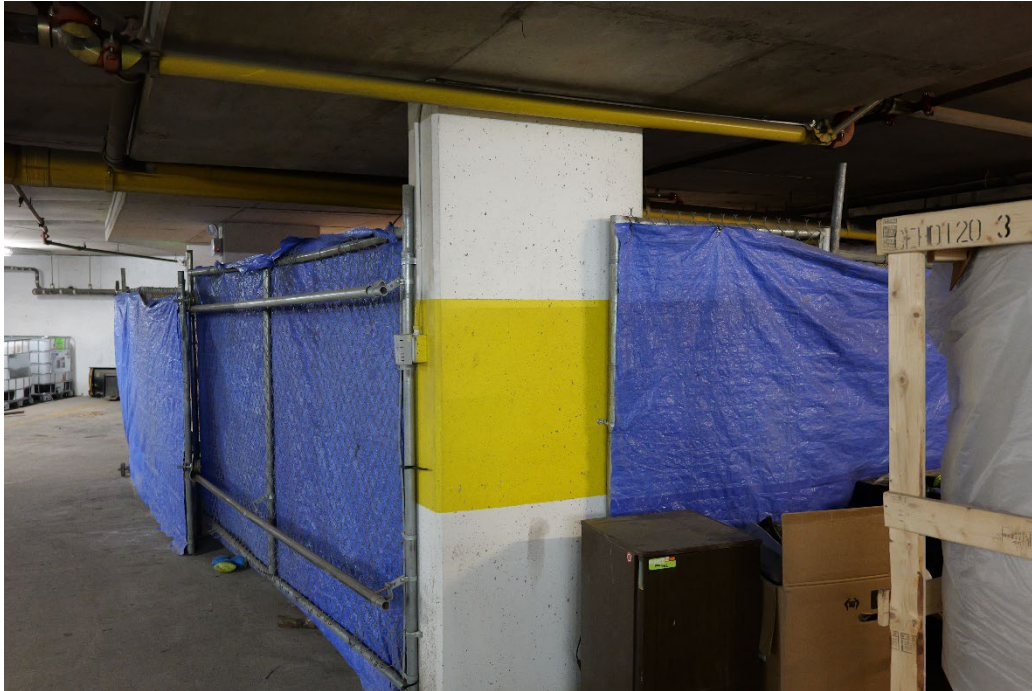
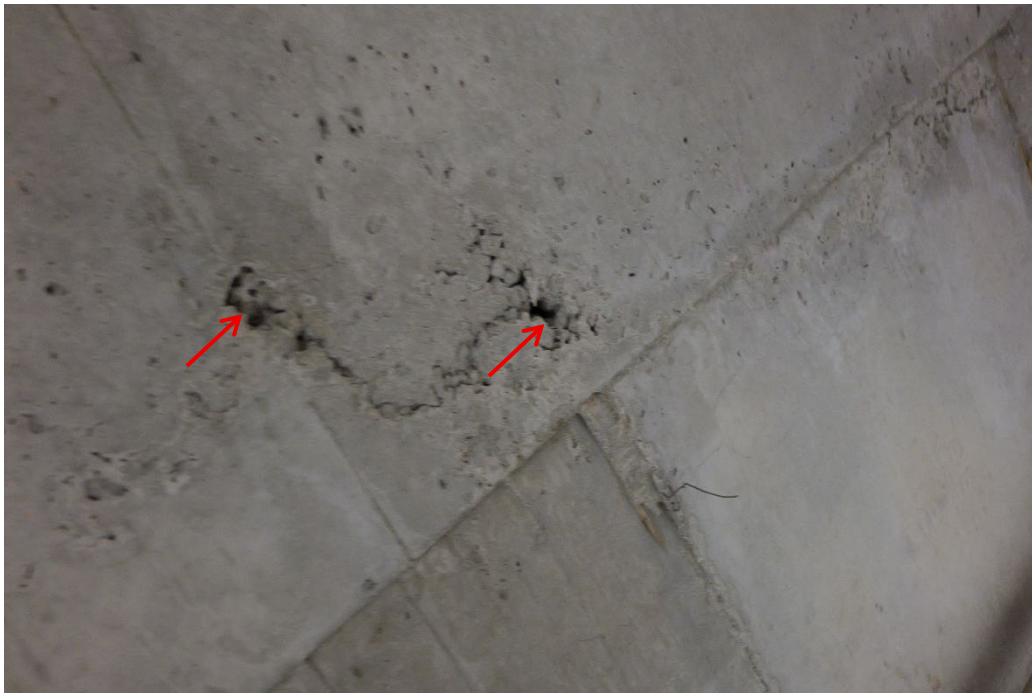
**Photographs 67 and 68** show **Location 34**. Portions of this area were inaccessible due to stored materials; however, localized honeycombing was observed in the accessible areas.

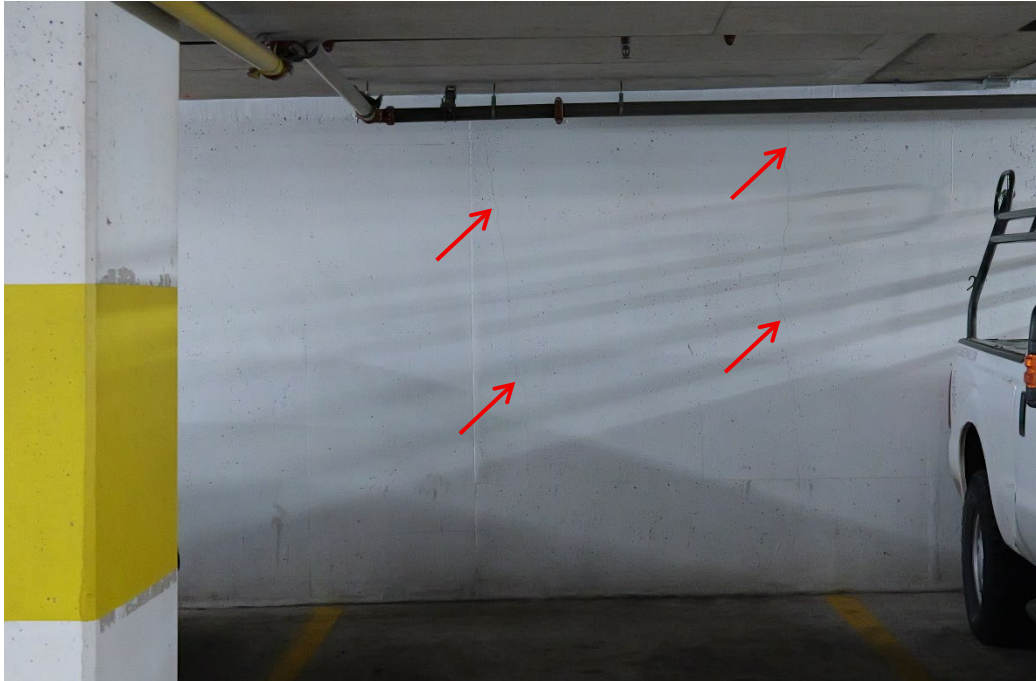
Photographs 69 and 70 show **Location 35**, where cracking was visible in the retaining wall.

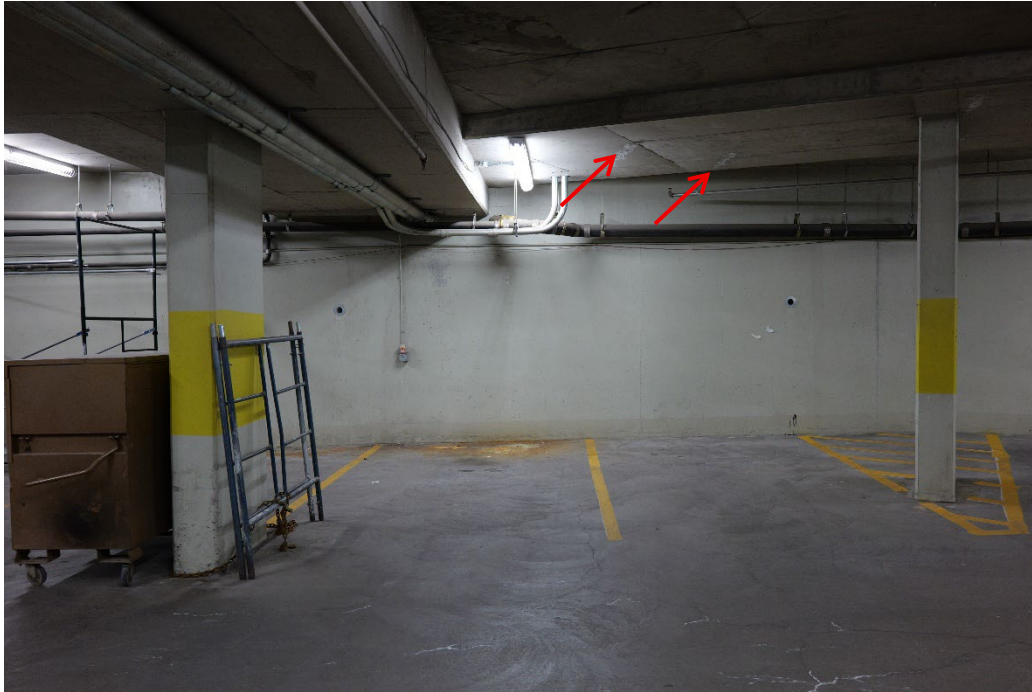
Photographs 79 and 80 show **Location 40**, where cracking and efflorescence were visible on the soffit of the elevated slab.
